Home Report

Single Survey

Property address	5 Chapelton Lane Seamill West Kilbride KA23 9LP
Customer	Robin Balmforth
Customer address	5 Chapelton Lane Seamill West Kilbride KA23 9LP
Prepared by	Shepherd Chartered Surveyors
Date of inspection	07/02/2025

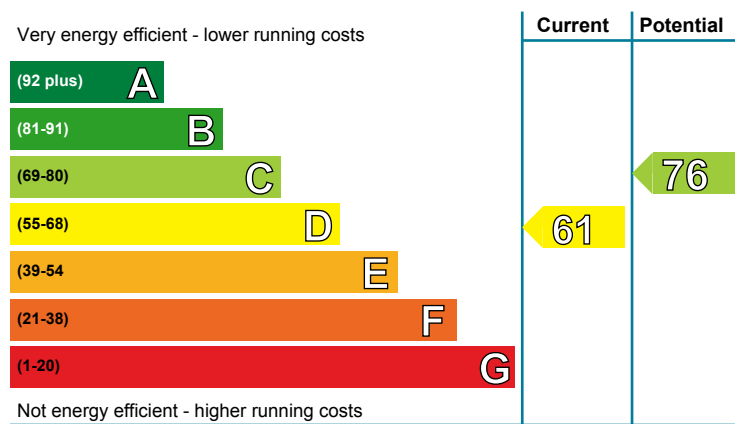
Energy Efficiency Rating

This graph shows the current efficiency of your home, taking into account both energy efficiency and fuel costs. The higher this rating, the lower your fuel bills are likely to be.

Your current rating is **band D (61)**. The average rating for EPCs in Scotland is **band D (61)**.

The potential rating shows the effect of undertaking all of the improvement measures listed within your recommendations report.

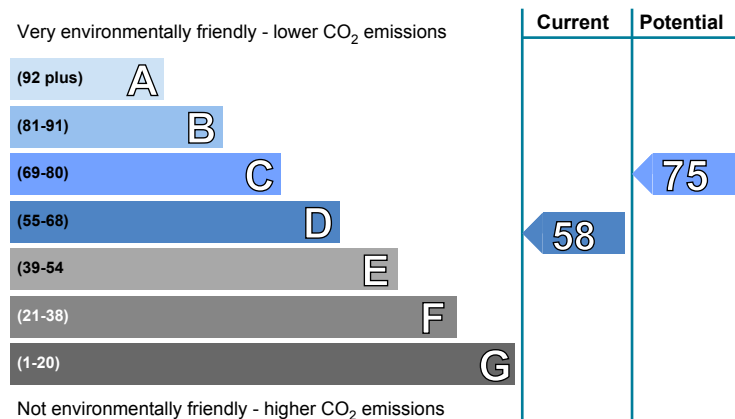
Environmental Impact (CO₂) Rating

This graph shows the effect of your home on the environment in terms of carbon dioxide (CO₂) emissions. The higher the rating, the less impact it has on the environment.
