Home Report

Scottish Single Survey

Single Survey

Property address	Parklands Failford Mauchline KA5 5TF
-------------------------	---

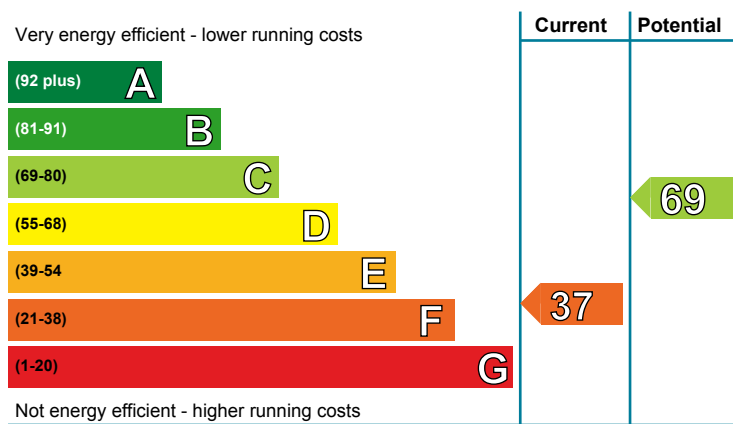
Energy Efficiency Rating

This graph shows the current efficiency of your home, taking into account both energy efficiency and fuel costs. The higher this rating, the lower your fuel bills are likely to be.

Your current rating is **band F (37)**. The average rating for EPCs in Scotland is **band D (61)**.

The potential rating shows the effect of undertaking all of the improvement measures listed within your recommendations report.
