Home Report

Scottish Single Survey

Property address	91 Kelvin Court Glasgow G12 0AH
Customer	J Carrick
Customer address	91 Kelvin Court Glasgow G12 0AH
Prepared by	Shepherd Chartered Surveyors
Date of inspection	20/02/2025

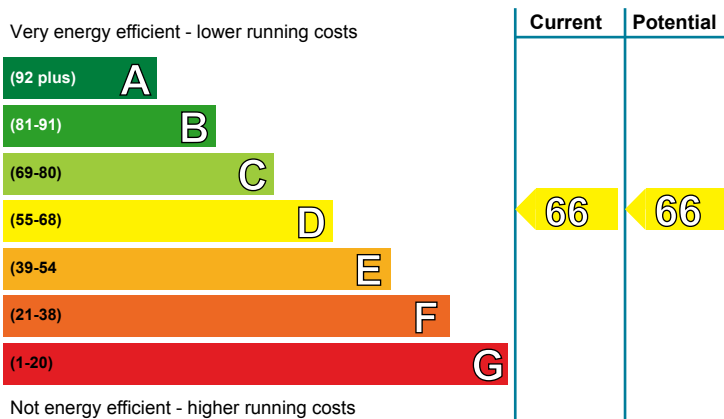
Energy Efficiency Rating

This graph shows the current efficiency of your home, taking into account both energy efficiency and fuel costs. The higher this rating, the lower your fuel bills are likely to be.

Your current rating is **band D (66)**. The average rating for EPCs in Scotland is **band D (61)**.

The potential rating shows the effect of undertaking all of the improvement measures listed within your recommendations report.

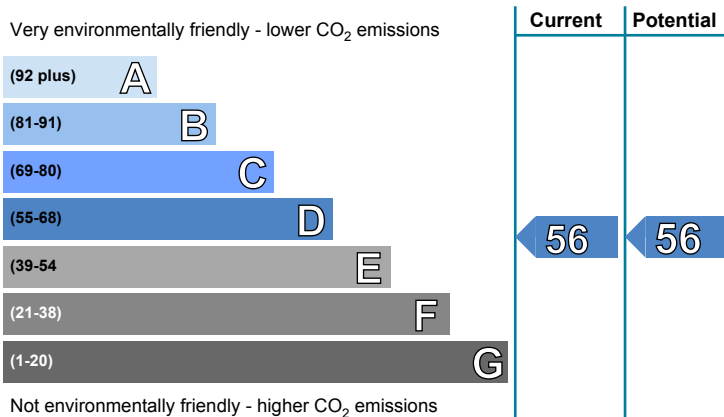
Environmental Impact (CO₂) Rating

This graph shows the effect of your home on the environment in terms of carbon dioxide (CO₂) emissions. The higher the rating, the less impact it has on the environment.
