Home Report

Scottish
Single Survey

Property address	32 Hole Road Coylton Ayr KA6 6JL
Customer	Mr & Mrs C Scott
Customer address	32 Hole Road Coylton Ayr KA6 6JL
Prepared by	Shepherd Chartered Surveyors
Date of inspection	24/02/2025

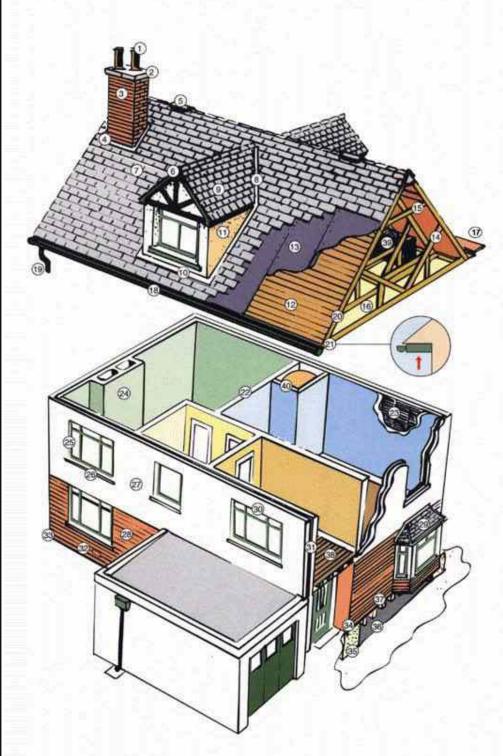
Sectional Diagram showing elements of a typical house

Reference may be made in this report to some or all of the above component parts of the property. This diagram may assist you in locating and understanding these items.

- 1) Chimney pots
- 2) Coping stone
- 3 Chimney head
- (4) Flashing
- 5) Ridge ventilation
- (6) Ridge board
- (7) Slates / tiles
- 8 Valley guttering
- 9 Dormer projection
- 10) Dormer flashing
- 11) Dormer cheeks
- (12) Sarking
- 13) Roof felt
- 14) Trusses
- (15) Collar
- 16) Insulation
- (17) Parapet gutter
- 18) Eaves guttering
- (19) Rainwater downpipe
- 20) Verge boards/skews
- 21) Soffit boards
- 22) Partition wall
- 23) Lath / plaster
- (24) Chimney breast
- 25) Window pointing
- 26) Window sills
- 27) Rendering
- (28) Brickwork / pointing
- (29) Bay window projection
- (30) Lintels
- (31) Cavity walls / wall ties
- 32) Subfloor ventilator
- (33) Damp proof course
- 34) Base course
- 35) Foundations
- 36) Solum
- Floor joists
- 38) Floorboards
- 9) Water tank
- (40) Hot water tank
