HOME REPORT

11 BROOMFIELD ROAD
AYR
KA7 2SP

Energy Performance Certificate (EPC)

11 BROOMFIELD ROAD, AYR, KA7 2SP

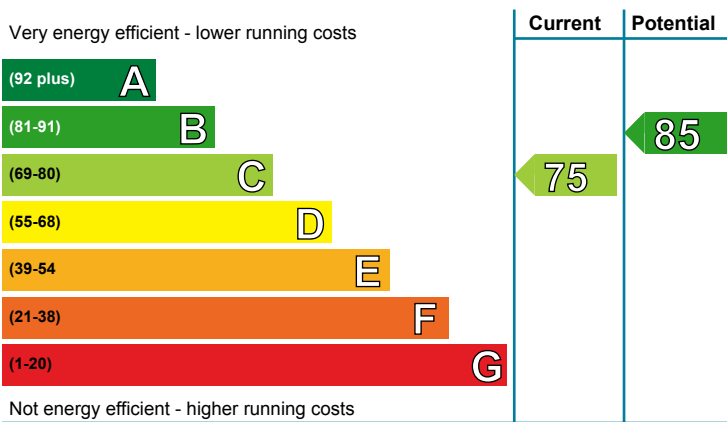
Energy Efficiency Rating

This graph shows the current efficiency of your home, taking into account both energy efficiency and fuel costs. The higher this rating, the lower your fuel bills are likely to be.

Your current rating is **band C (75)**. The average rating for EPCs in Scotland is **band D (61)**.

The potential rating shows the effect of undertaking all of the improvement measures listed within your recommendations report.
