HOME REPORT

11 PORTLAND TERRACE
TROON
KA10 6AJ

11 PORTLAND TERRACE, TROON, KA10 6AJ

Single Survey

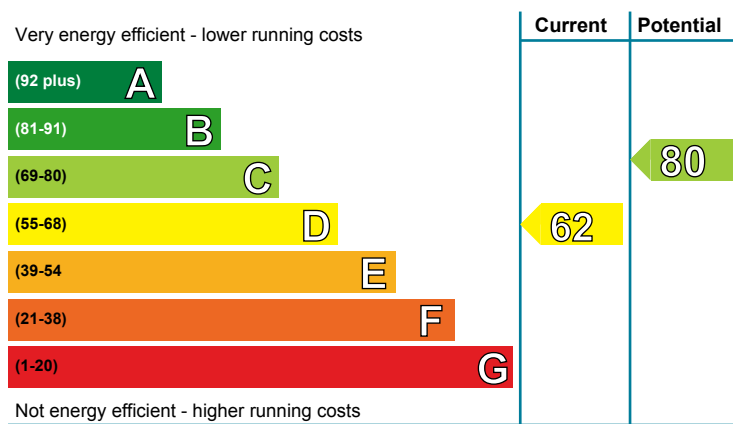
Energy Efficiency Rating

This graph shows the current efficiency of your home, taking into account both energy efficiency and fuel costs. The higher this rating, the lower your fuel bills are likely to be.

Your current rating is **band D (62)**. The average rating for EPCs in Scotland is **band D (61)**.

The potential rating shows the effect of undertaking all of the improvement measures listed within your recommendations report.

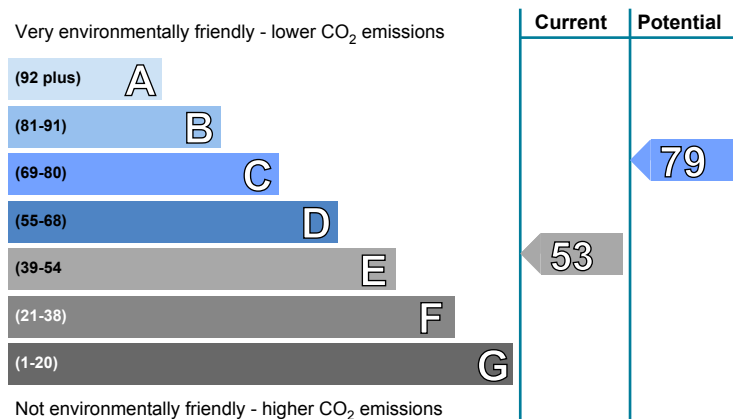
Environmental Impact (CO₂) Rating

This graph shows the effect of your home on the environment in terms of carbon dioxide (CO₂) emissions. The higher the rating, the less impact it has on the environment.

Your current rating is **band E (53)**. The average rating for EPCs in Scotland is **band D (59)**.

The potential rating shows the effect of undertaking all of the improvement measures listed within your recommendations report.
