Home Report

Scottish Single Survey

Property address	2/2 165 Kenmure Street Glasgow G41 2LE
Customer	Alice Jenner
Customer address	2/2 165 Kenmure Street Glasgow G41 2LE
Prepared by	Shepherd Chartered Surveyors
Date of inspection	05/03/2025

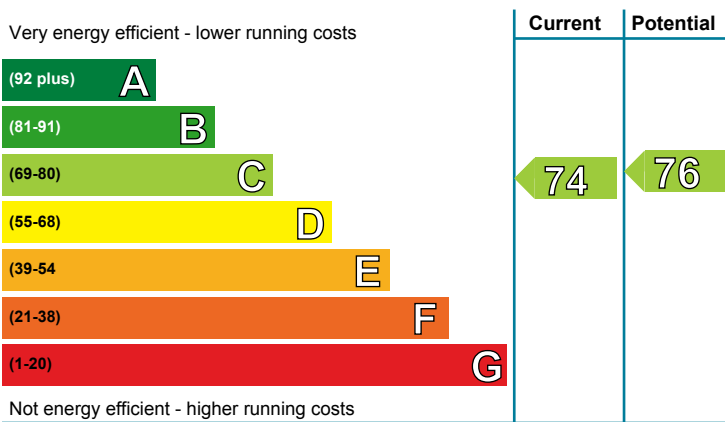
Energy Efficiency Rating

This graph shows the current efficiency of your home, taking into account both energy efficiency and fuel costs. The higher this rating, the lower your fuel bills are likely to be.

Your current rating is **band C (74)**. The average rating for EPCs in Scotland is **band D (61)**.

The potential rating shows the effect of undertaking all of the improvement measures listed within your recommendations report.

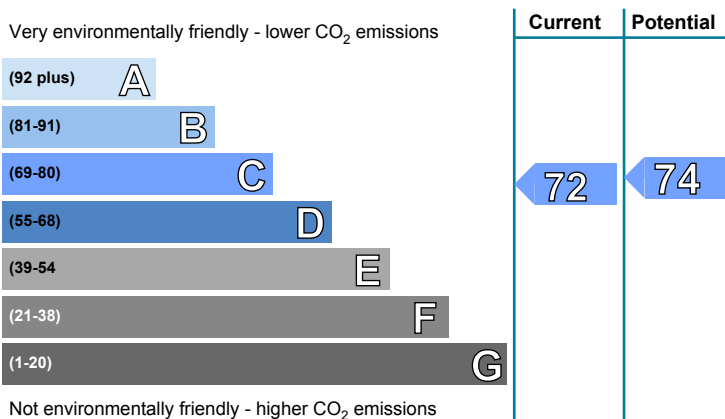
Environmental Impact (CO₂) Rating

This graph shows the effect of your home on the environment in terms of carbon dioxide (CO₂) emissions. The higher the rating, the less impact it has on the environment.
