YOUR ONESURVEY  
**HOME REPORT**

1a Lawers Road  
Renfrew  
PA4 0PQ

# SINGLE SURVEY

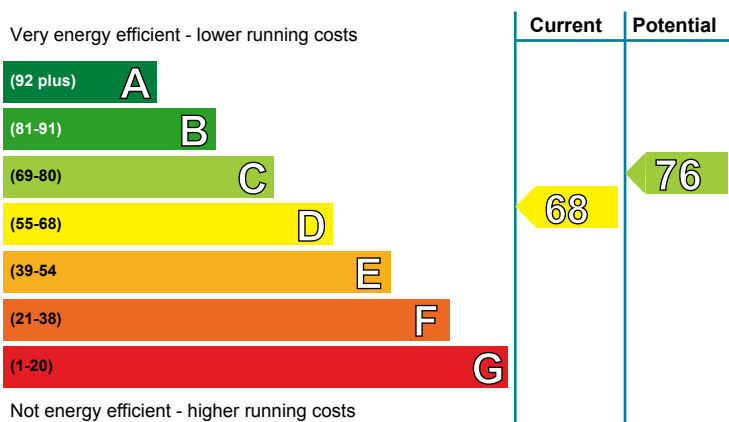
## Energy Efficiency Rating

This graph shows the current efficiency of your home, taking into account both energy efficiency and fuel costs. The higher this rating, the lower your fuel bills are likely to be.

Your current rating is **band D (68)**. The average rating for EPCs in Scotland is **band D (61)**.

The potential rating shows the effect of undertaking all of the improvement measures listed within your recommendations report.

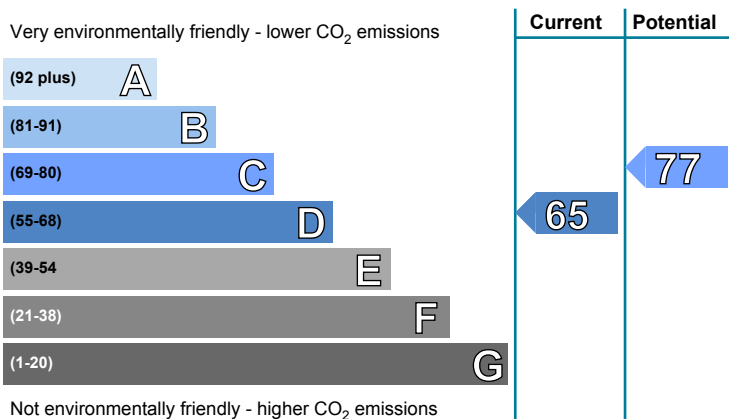
## Environmental Impact (CO<sub>2</sub>) Rating

This graph shows the effect of your home on the environment in terms of carbon dioxide (CO<sub>2</sub>) emissions. The higher the rating, the less impact it has on the environment.
