Home Report

Single Survey

Property address	111 Lomondside Avenue Clarkston Glasgow G76 7UH
Customer	MR D STANG
Customer address	111 Lomondside Avenue Clarkston Glasgow G76 7UH
Prepared by	Shepherd Chartered Surveyors
Date of inspection	27/02/2025

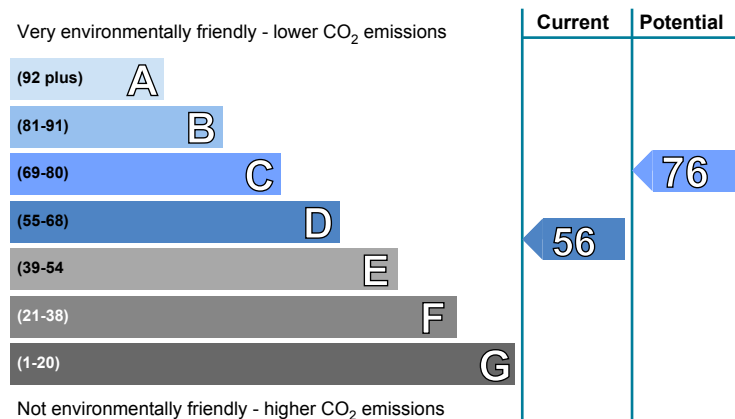
Environmental Impact (CO₂) Rating

This graph shows the effect of your home on the environment in terms of carbon dioxide (CO₂) emissions. The higher the rating, the less impact it has on the environment.
