Home Report

Single Survey

Property address	14 Nethermains Road Milngavie Glasgow G62 6NP
Customer	Ms Susan Fenwick
Customer address	14 Nethermains Road Milngavie Glasgow G62 6NP
Prepared by	Shepherd Chartered Surveyors
Date of inspection	26/05/2025

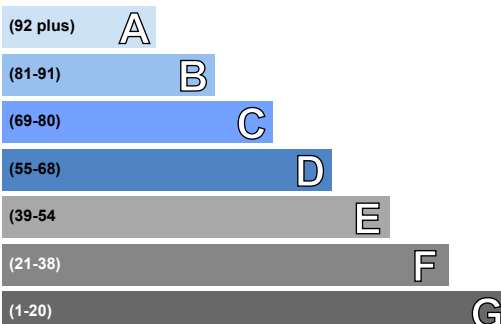
Environmental Impact (CO₂) Rating

Very environmentally friendly - lower CO₂ emissions

Current	Potential
55	79
