# Home Report

# Scottish Single Survey

Property address	1/1 24 Westclyffe Street Glasgow G41 2EE
Customer	Mr and Mrs McClure
Customer address	1/1 24 Westclyffe Street Glasgow G41 2EE
Prepared by	Shepherd Chartered Surveyors
Date of inspection	07/04/2025

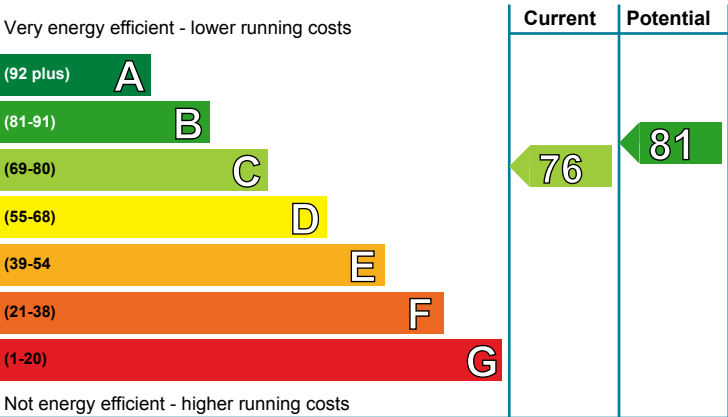
## Energy Efficiency Rating

This graph shows the current efficiency of your home, taking into account both energy efficiency and fuel costs. The higher this rating, the lower your fuel bills are likely to be.

Your current rating is **band C (76)**. The average rating for EPCs in Scotland is **band D (61)**.

The potential rating shows the effect of undertaking all of the improvement measures listed within your recommendations report.

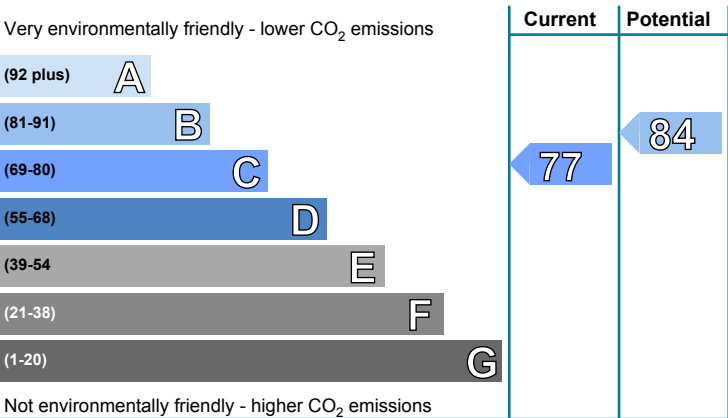
## Environmental Impact (CO<sub>2</sub>) Rating

This graph shows the effect of your home on the environment in terms of carbon dioxide (CO<sub>2</sub>) emissions. The higher the rating, the less impact it has on the environment.
