YOUR ONESURVEY
HOME REPORT

Moidart
Tandlehill Road
Kilbarchan, Johnstone
PA10 2DD

SINGLE SURVEY

Single Survey

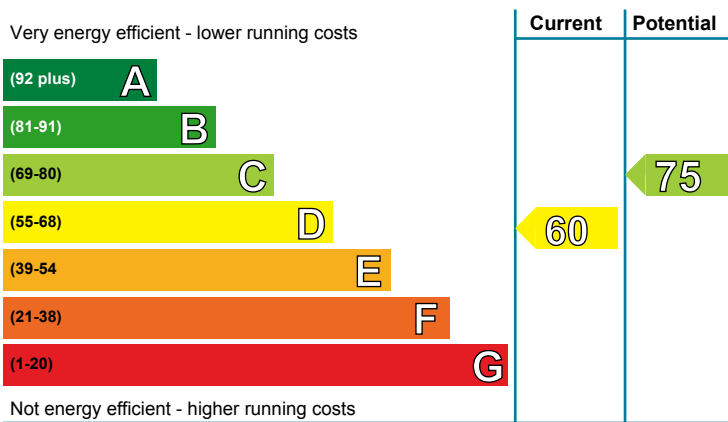
Energy Efficiency Rating

This graph shows the current efficiency of your home, taking into account both energy efficiency and fuel costs. The higher this rating, the lower your fuel bills are likely to be.

Your current rating is **band D (60)**. The average rating for EPCs in Scotland is **band D (61)**.

The potential rating shows the effect of undertaking all of the improvement measures listed within your recommendations report.

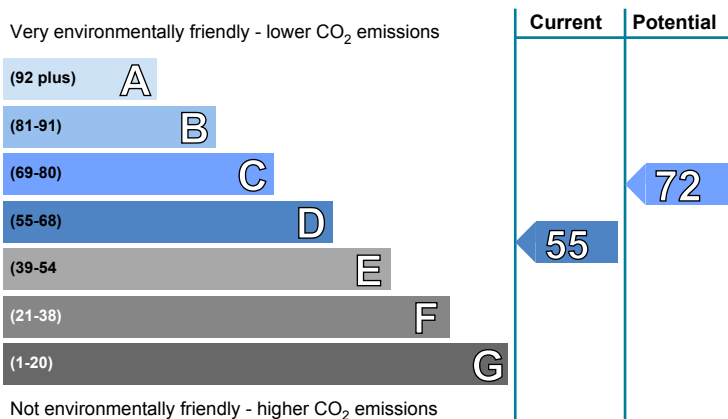
Environmental Impact (CO₂) Rating

This graph shows the effect of your home on the environment in terms of carbon dioxide (CO₂) emissions. The higher the rating, the less impact it has on the environment.
