# YOUR ONESURVEY HOME REPORT

425 Crow Road Broomhill Glasgow G11 7DZ

# SINGLE Survey

# Single Survey

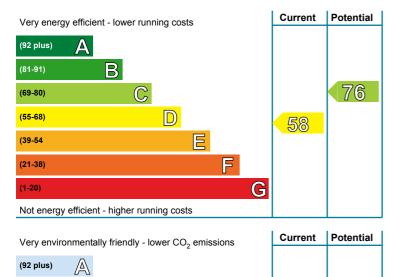
#### **Energy Efficiency Rating**

This graph shows the current efficiency of your home, taking into account both energy efficiency and fuel costs. The higher this rating, the lower your fuel bills are likely to be.
