Home Report

Single Survey

Property address	1/2 2 Northland Avenue Glasgow G14 9BN
Customer	D Rami & P Di Crescenzo
Customer address	1/2 2 Northland Avenue Glasgow G14 9BN
Prepared by	Shepherd Chartered Surveyors
Date of inspection	11/04/2025

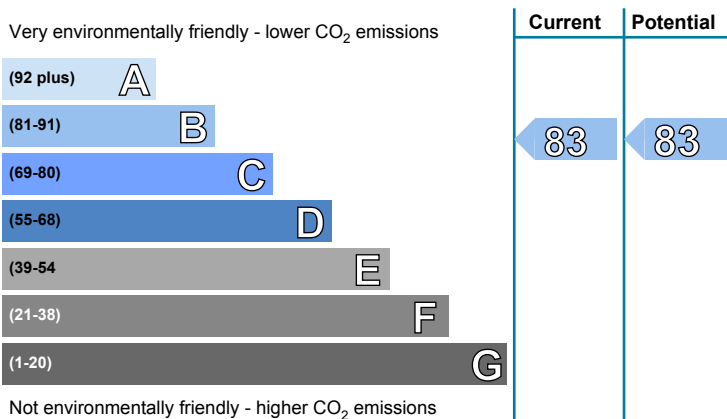
Environmental Impact (CO₂) Rating

This graph shows the effect of your home on the environment in terms of carbon dioxide (CO₂) emissions. The higher the rating, the less impact it has on the environment.
