# Home Report

# Single Survey

<b>Property Address</b>	11B Martnaham Way, Ayr, KA7 4TY
<b>Reference</b>	1070483
<b>Customer Name</b>	Laura Bailie
<b>Date of Inspection</b>	23rd May 2025
<b>Surveyor's name, qualifications and office</b>	Mark Rutherford MA (Hons) MRICS  DM Hall LLP Chartered Surveyors 15 Miller Road Ayr KA7 2AX  Tel: 01292 286974  email: ayrresidential@dmhall.co.uk
<b>Prepared By</b>	DM Hall LLP

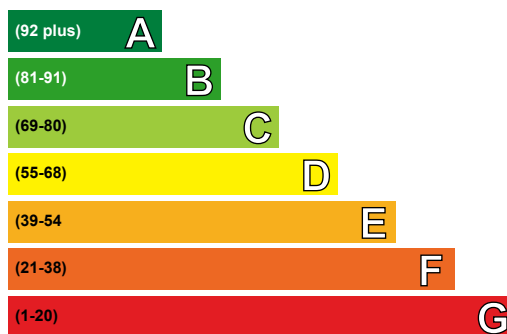
Very energy efficient - lower running costs

Not energy efficient - higher running costs

Current	Potential
84	84

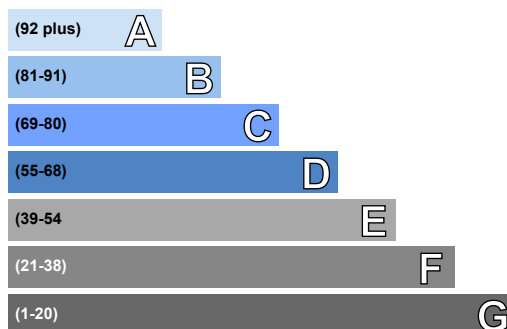
Very environmentally friendly - lower CO<sub>2</sub> emissions

Not environmentally friendly - higher CO<sub>2</sub> emissions

Current	Potential
85	85
