Home Report

Single Survey

Property address	327 Clarkston Road Glasgow G44 3EJ
Customer	Paul Mitchell
Customer address	327 Clarkston Road Glasgow G44 3EJ
Prepared by	Shepherd Chartered Surveyors
Date of inspection	23/05/2025

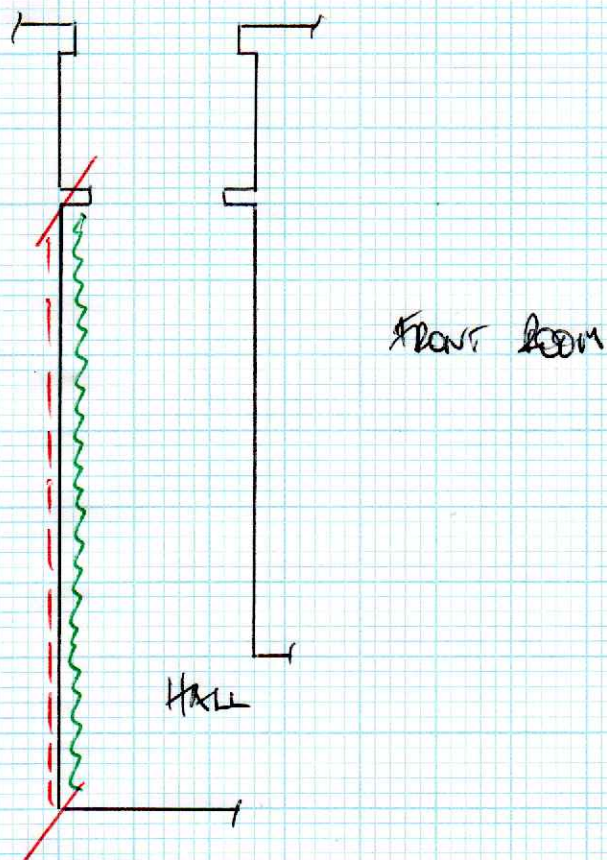
327 CLARKSON ROAD
GUYANA

--- DAMP PROOF COURSE

— VERTICAL DPC
