YOUR ONESURVEY  
**HOME REPORT**

Flat 2/3  
1 Mount Zion  
Quarrier's Village, Bridge of Weir  
PA11 3TD

# SINGLE SURVEY

A report on the condition of the property, with categories being rated from 1 to 3.

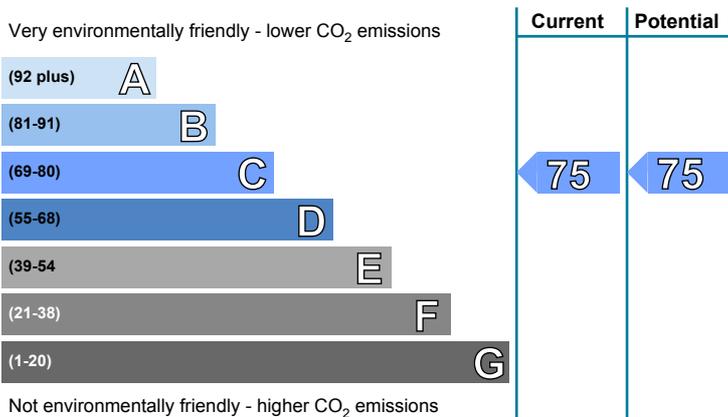
## Environmental Impact (CO<sub>2</sub>) Rating

This graph shows the effect of your home on the environment in terms of carbon dioxide (CO<sub>2</sub>) emissions. The higher the rating, the less impact it has on the environment.
