## **Home Report**

Scottish
Single Survey

## survey report on:

| Property address | 60 Main Street Ochiltree Cumnock KA18 2PB |

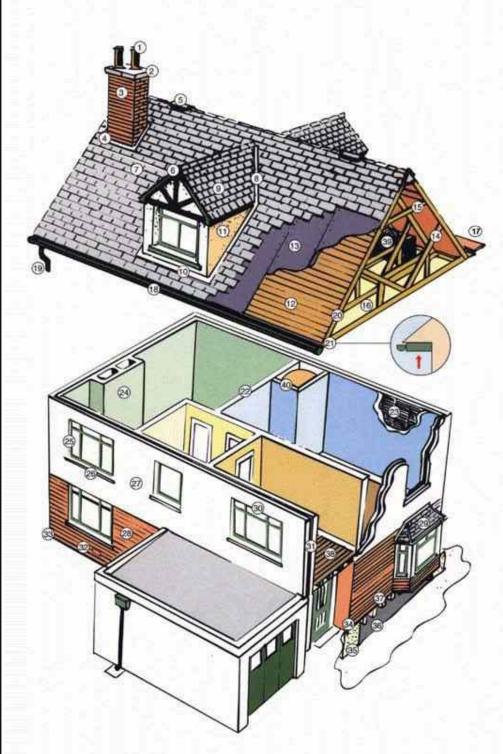
## Sectional Diagram showing elements of a typical house

Reference may be made in this report to some or all of the above component parts of the property. This diagram may assist you in locating and understanding these items.

- 1) Chimney pots
- 2) Coping stone
- 3 Chimney head
- (4) Flashing
- 5) Ridge ventilation
- (6) Ridge board
- (7) Slates / tiles
- 8 Valley guttering
- 9 Dormer projection
- 10 Dormer flashing
- 11 Dormer cheeks
- (12) Sarking
- (13) Roof felt
- 14) Trusses
- (15) Collar
- 16) Insulation
- (17) Parapet gutter
- (18) Eaves guttering
- 19 Rainwater downpipe
- 20) Verge boards/skews
- 21) Soffit boards
- 22) Partition wall
- 23) Lath / plaster
- (24) Chimney breast
- 25) Window pointing
- 26) Window sills
- 27) Rendering
- (28) Brickwork / pointing
- 29 Bay window projection
- (30) Lintels
- (31) Cavity walls / wall ties
- 32) Subfloor ventilator
- (33) Damp proof course
- 34) Base course
- (35) Foundations
- 36) Solum
- 37) Floor joists
- 38) Floorboards
- 39) Water tank
- 40) Hot water tank
