Home Report

Scottish Single Survey

| Property address | 0/1 30 Lanton Road Glasgow G43 2SR |
| Date of inspection | 17/06/2025 |

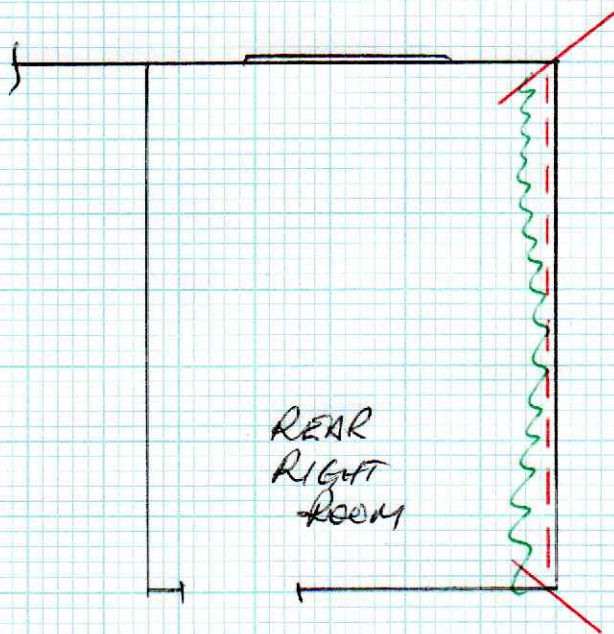
——— VERTICAL DPC

~~~~~ REPLASTER/MEMBRANE UP TO 1" HIGH
