# YOUR ONESURVEY HOME REPORT

Flat 1c  
21 Milverton Road  
Giffnock, Glasgow  
G46 7JN

# SINGLE SURVEY

# Single Survey

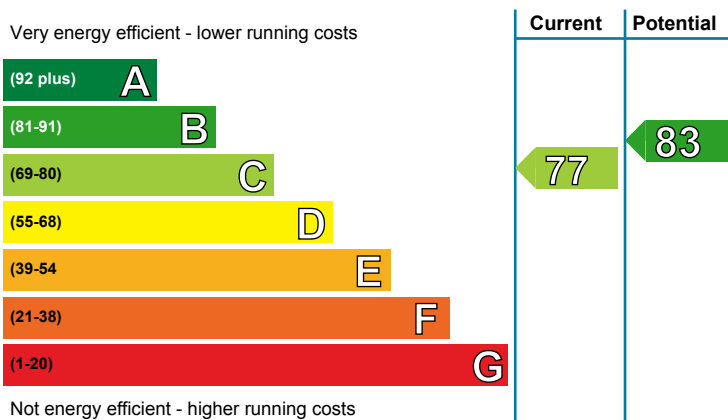
## Energy Efficiency Rating

This graph shows the current efficiency of your home, taking into account both energy efficiency and fuel costs. The higher this rating, the lower your fuel bills are likely to be.

The potential rating shows the effect of undertaking all of the improvement measures listed within your recommendations report.

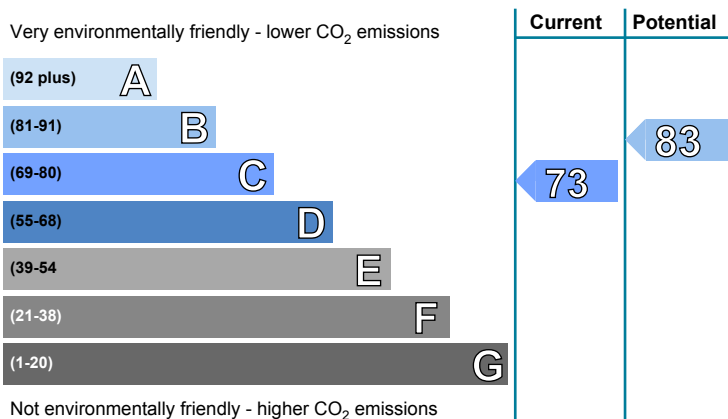
## Environmental Impact (CO<sub>2</sub>) Rating

This graph shows the effect of your home on the environment in terms of carbon dioxide (CO<sub>2</sub>) emissions. The higher the rating, the less impact it has on the environment.
