Home Report

Scottish
Single Survey

Property address	17b Silverdale Gardens Largs KA30 9LT
Γ-	
Customer	Estate of Judith Marshall
Customer address	17b Silverdale Gardens Largs KA30 9LT
Prepared by	Shepherd Chartered Surveyors
Date of inspection	03/06/2025

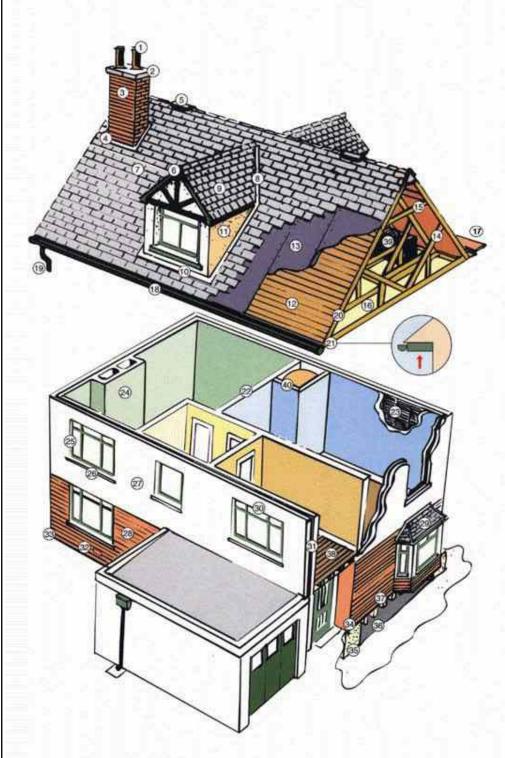
Sectional Diagram showing elements of a typical house

Reference may be made in this report to some or all of the above component parts of the property. This diagram may assist you in locating and understanding these items.

- 1) Chimney pots
- 2) Coping stone
- (3) Chimney head
- 4 Flashing
- 5) Ridge ventilation
- 6 Ridge board
- (7) Slates / tiles
- 8 Valley guttering
- 9 Dormer projection
- 10 Dormer flashing
- 11) Dormer cheeks
- (12) Sarking
- 13) Roof felt
- (14) Trusses
- (15) Collar
- 16) Insulation
- (17) Parapet gutter
- (18) Eaves guttering
- 19 Rainwater downpipe
- 20) Verge boards/skews
- 21) Soffit boards
- 22) Partition wall
- 23) Lath / plaster
- (24) Chimney breast
- 25) Window pointing
- 26) Window sills
- 27) Rendering
- (28) Brickwork / pointing
- 29 Bay window projection
- (30) Lintels
- (31) Cavity walls / wall ties
- 32) Subfloor ventilator
- (33) Damp proof course
- 34) Base course
- (35) Foundations
- 36) Solum
- Floor joists
- 38) Floorboards
- 39) Water tank
- 40 Hot water tank
