# YOUR ONESURVEY HOME REPORT

Seton House  
Croftamie  
G63 0EZ

# SINGLE SURVEY

# Single Survey

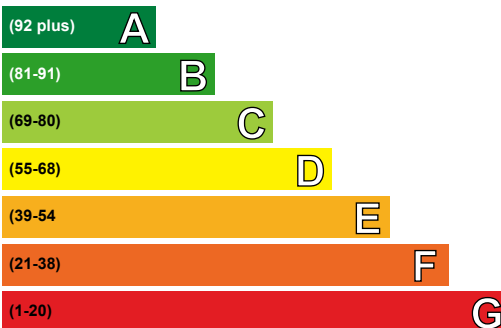
Very energy efficient - lower running costs

Not energy efficient - higher running costs

Current	Potential
83	89

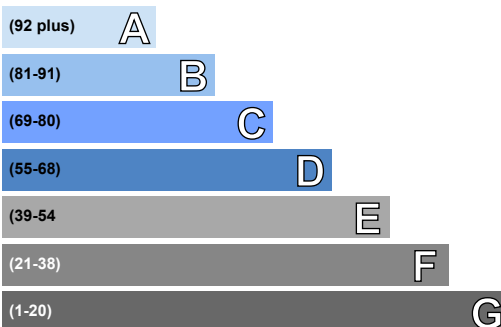
Very environmentally friendly - lower CO<sub>2</sub> emissions

Not environmentally friendly - higher CO<sub>2</sub> emissions

Current	Potential
70	77
