# Home Report

# Single Survey

<b>Property Address</b>	Flat C, 161 Welbeck Crescent, Troon, Ayrshire, KA10 6AP
<b>Reference</b>	1123044
<b>Customer Name</b>	Executry of John Barry Brown
<b>Date of Inspection</b>	27th June 2025
<b>Surveyor's name, qualifications and office</b>	Claudia Balmforth BSc (Hons) MRICS  DM Hall LLP Chartered Surveyors Eldo House, Monkton Road, Prestwick, KA9 2PB  Tel: 01292 286974  email: ayrshireresidential@dmhall.co.uk
<b>Prepared By</b>	DM Hall LLP

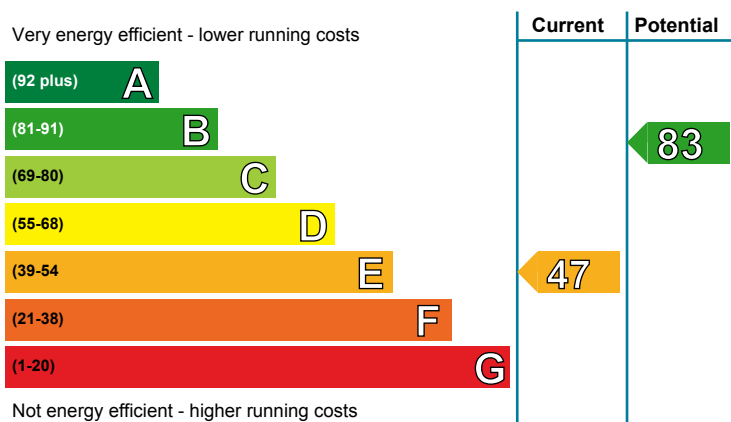
## Energy Efficiency Rating

This graph shows the current efficiency of your home, taking into account both energy efficiency and fuel costs. The higher this rating, the lower your fuel bills are likely to be.

Your current rating is **band E (47)**. The average rating for EPCs in Scotland is **band D (61)**.

The potential rating shows the effect of undertaking all of the improvement measures listed within your recommendations report.

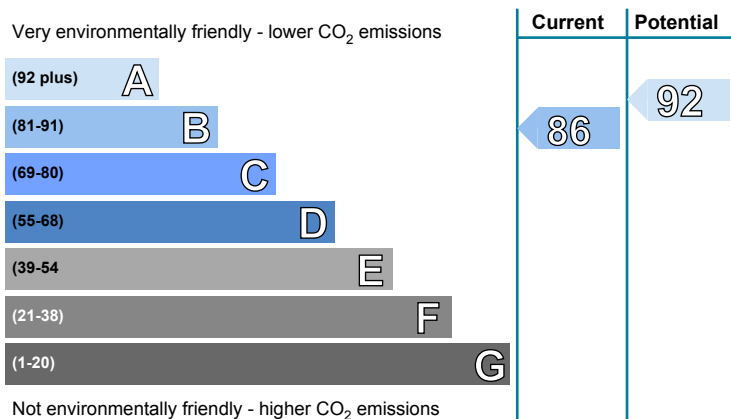
## Environmental Impact (CO<sub>2</sub>) Rating

This graph shows the effect of your home on the environment in terms of carbon dioxide (CO<sub>2</sub>) emissions. The higher the rating, the less impact it has on the environment.
