YOUR ONESURVEY
HOME REPORT

22 Gorget Quadrant
Glasgow
G13 2AQ

HOME REPORT

Single Survey

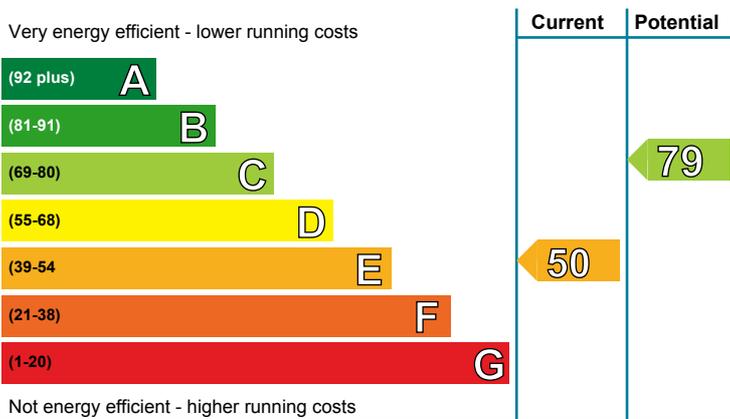
Energy Efficiency Rating

This graph shows the current efficiency of your home, taking into account both energy efficiency and fuel costs. The higher this rating, the lower your fuel bills are likely to be.

Your current rating is **band E (50)**. The average rating for EPCs in Scotland is **band D (61)**.

The potential rating shows the effect of undertaking all of the improvement measures listed within your recommendations report.
