Home Report

Scottish Single Survey

Single Survey

| Property address | Blackdyke Farm Sorn Mauchline KA5 6HL |

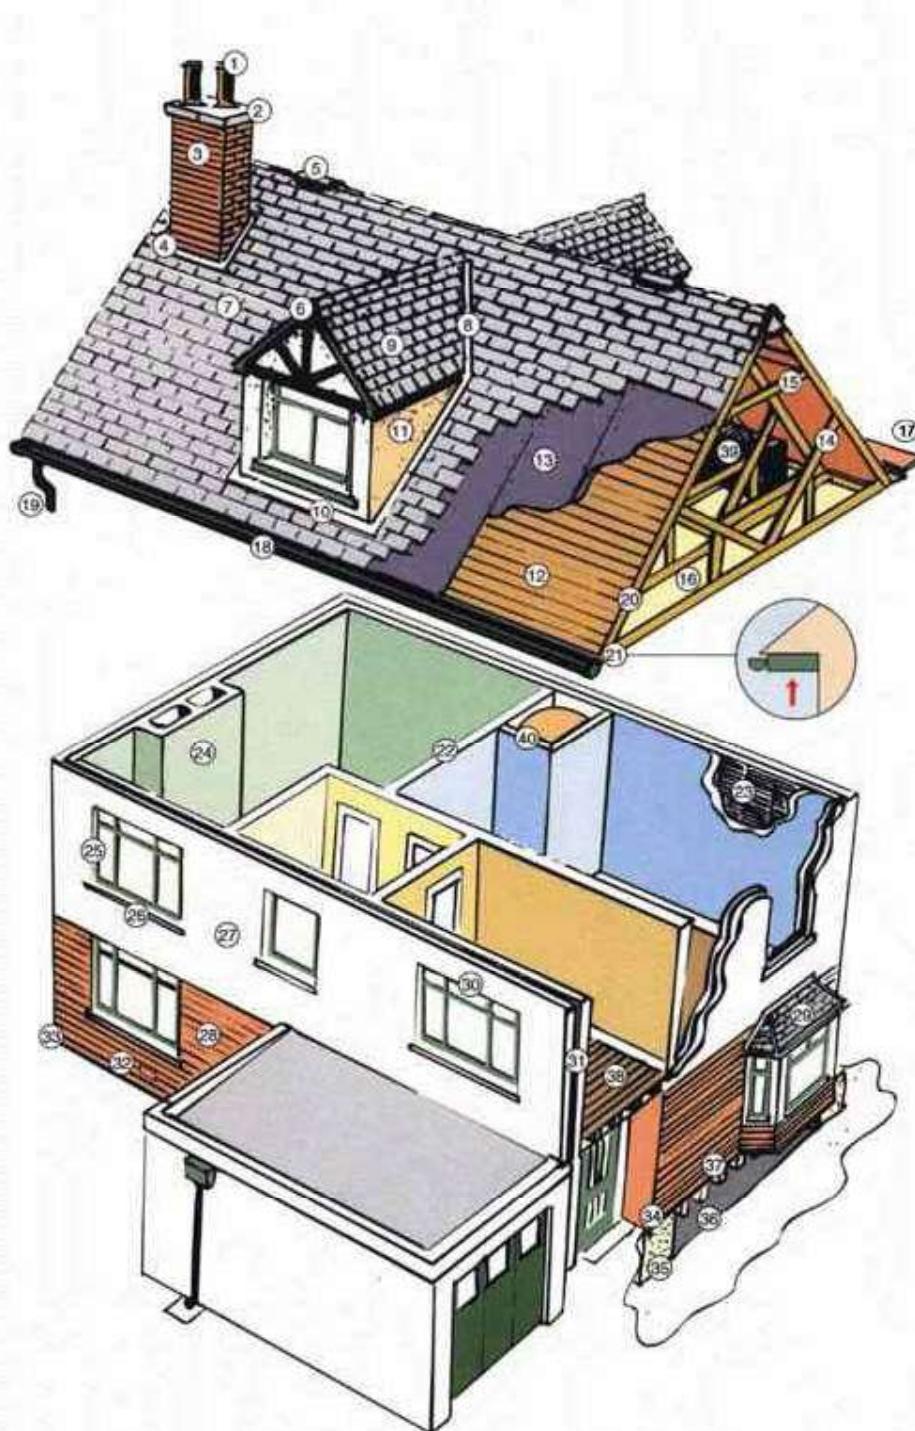
Sectional Diagram showing elements of a typical house

- 1 Chimney pots
- 2 Coping stone
- 3 Chimney head
- 4 Flashing
- 5 Ridge ventilation
- 6 Ridge board
- 7 Slates / tiles
- 8 Valley guttering
- 9 Dormer projection
- 10 Dormer flashing
- 11 Dormer cheeks
- 12 Sarking
- 13 Roof felt
- 14 Trusses
- 15 Collar
- 16 Insulation
- 17 Parapet gutter
- 18 Eaves guttering
- 19 Rainwater downpipe
- 20 Verge boards /skews
- 21 Soffit boards
- 22 Partition wall
- 23 Lath / plaster
- 24 Chimney breast
- 25 Window pointing
- 26 Window sills
- 27 Rendering
- 28 Brickwork / pointing
- 29 Bay window projection
- 30 Lintels
- 31 Cavity walls / wall ties
- 32 Subfloor ventilator
- 33 Damp proof course
- 34 Base course
- 35 Foundations
- 36 Solum
- 37 Floor joists
- 38 Floorboards
- 39 Water tank
- 40 Hot water tank

Reference may be made in this report to some or all of the above component parts of the property. This diagram may assist you in locating and understanding these items.

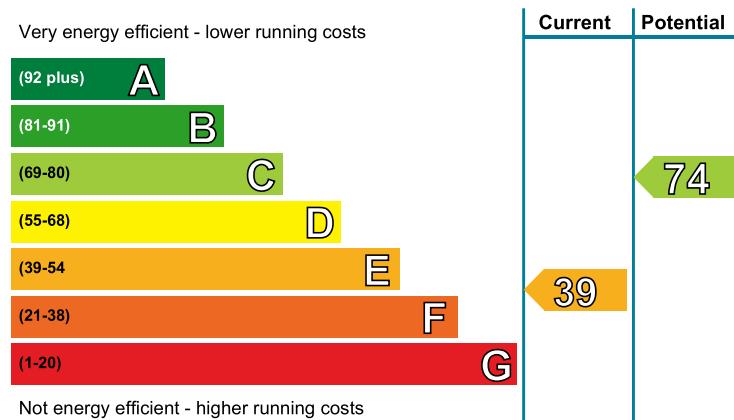
Energy Efficiency Rating

This graph shows the current efficiency of your home, taking into account both energy efficiency and fuel costs. The higher this rating, the lower your fuel bills are likely to be.

Your current rating is **band E (39)**. The average rating for EPCs in Scotland is **band D (61)**.

The potential rating shows the effect of undertaking all of the improvement measures listed within your recommendations report.

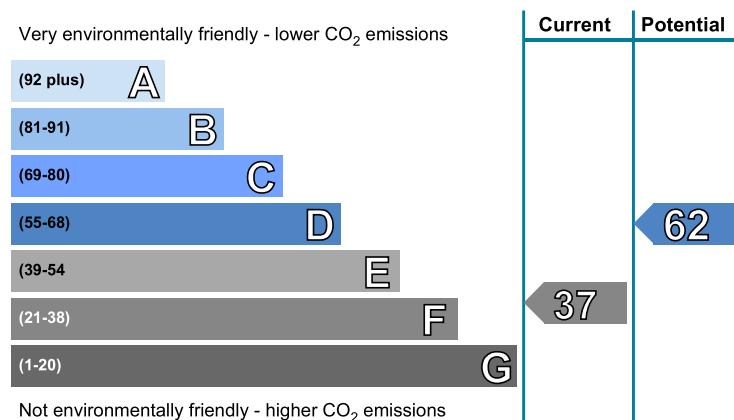
Environmental Impact (CO₂) Rating

This graph shows the effect of your home on the environment in terms of carbon dioxide (CO₂) emissions. The higher the rating, the less impact it has on the environment.
