Home Report

Single Survey

Property address	6 Craigneil Drive Prestwick KA9 1LZ
Customer	Mrs E Gray
Customer address	6 Craigneil Drive Prestwick KA9 1LZ
Prepared by	Shepherd Chartered Surveyors
Date of inspection	28/01/2026

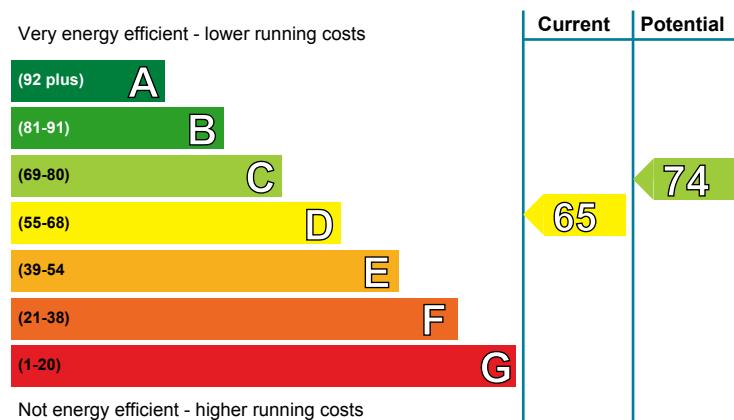
Energy Efficiency Rating

This graph shows the current efficiency of your home, taking into account both energy efficiency and fuel costs. The higher this rating, the lower your fuel bills are likely to be.

Your current rating is **band D (65)**. The average rating for EPCs in Scotland is **band D (61)**.

The potential rating shows the effect of undertaking all of the improvement measures listed within your recommendations report.

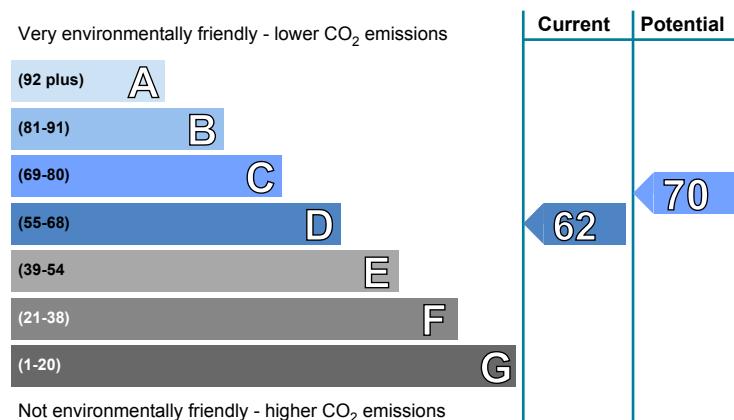
Environmental Impact (CO₂) Rating

This graph shows the effect of your home on the environment in terms of carbon dioxide (CO₂) emissions. The higher the rating, the less impact it has on the environment.
