YOUR ONESURVEY
HOME REPORT

15 Bowfield Road
West Kilbride
KA23 9LB

Single Survey

Surveyor Reference	SA/9740
Customer	Mrs. Dana Swanson
Selling address	15 Bowfield Road West Kilbride KA23 9LB
Date of Inspection	30/10/2025
Prepared by	Nick Davis, MSc MRICS Saltcoats - Allied Surveyors Scotland Ltd

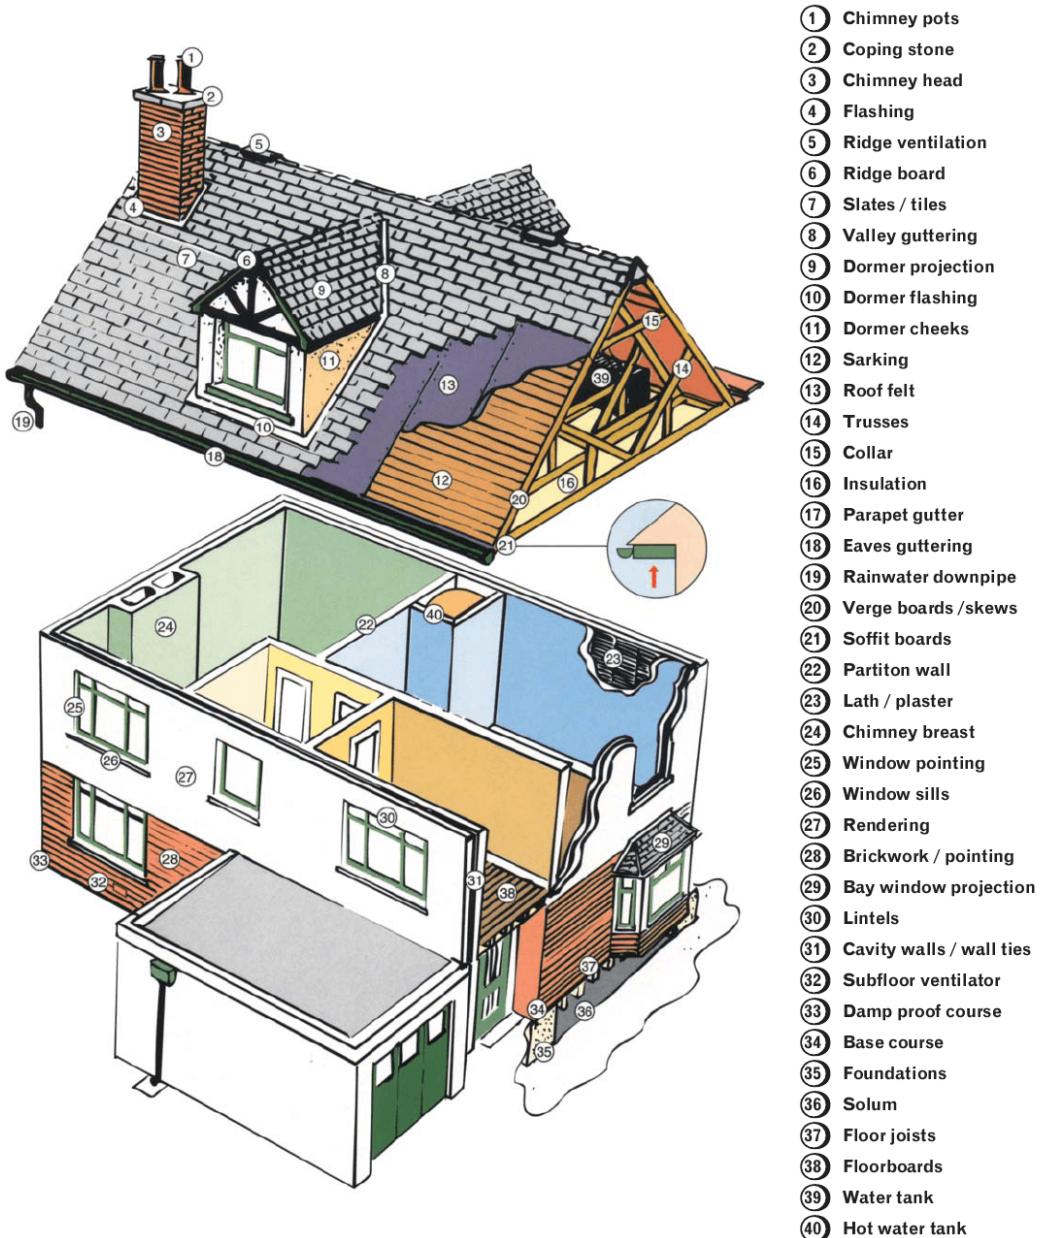
Sectional Diagram showing elements of a typical house

Reference may be made in this report to some or all of the above component parts of the property. This diagram may assist you in locating and understanding these items.
