Home Report

Scottish
Single Survey

Property address	19 Annbank Road Mossblown Ayr KA6 5BH
Customer	Ms J Aitken
Customer address	19 Annbank Road Mossblown Ayr KA6 5BH
Prepared by	Shepherd Chartered Surveyors
Date of inspection	06/10/2025

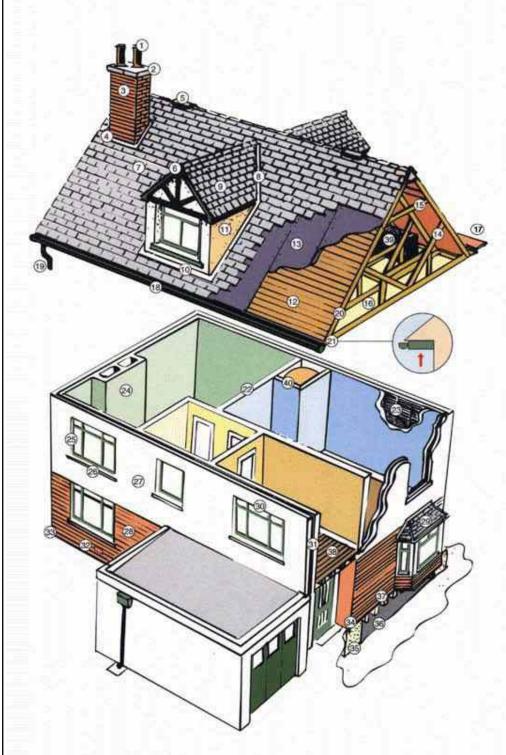
Sectional Diagram showing elements of a typical house

Reference may be made in this report to some or all of the above component parts of the property. This diagram may assist you in locating and understanding these items.

- 1) Chimney pots
- 2) Coping stone
- 3) Chimney head
- (4) Flashing
- 5) Ridge ventilation
- 6 Ridge board
- (7) Slates / tiles
- 8 Valley guttering
- Dormer projection
- 10 Dormer flashing
- 11) Dormer cheeks
- (12) Sarking
- 13) Roof felt
- (14) Trusses
- (15) Collar
- 16) Insulation
- (17) Parapet gutter
- 18) Eaves guttering
- (19) Rainwater downpipe
- 20) Verge boards/skews
- 21) Soffit boards
- 22) Partition wall
- 23) Lath / plaster
- (24) Chimney breast
- 25) Window pointing
- 26) Window sills
- 27) Rendering
- (28) Brickwork / pointing
- 29) Bay window projection
- (30) Lintels
- (31) Cavity walls / wall ties
- 32) Subfloor ventilator
- (33) Damp proof course
- 34) Base course
- 35) Foundations
- 36) Solum
- 37) Floor joists
- 8) Floorboards
- 39) Water tank
- 40) Hot water tank
