Home Report

Single Survey

Property address	2 Drumby Drive Clarkston Glasgow G76 7HL
Customer	Patrick Oberg
Customer address	2 Drumby Drive Clarkston Glasgow G76 7HL
Prepared by	Shepherd Chartered Surveyors
Date of inspection	28/11/2025

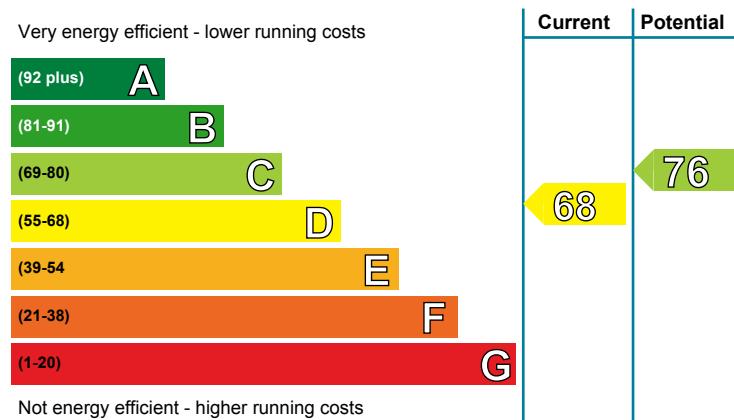
Energy Efficiency Rating

This graph shows the current efficiency of your home, taking into account both energy efficiency and fuel costs. The higher this rating, the lower your fuel bills are likely to be.

Your current rating is **band D (68)**. The average rating for EPCs in Scotland is **band D (61)**.

The potential rating shows the effect of undertaking all of the improvement measures listed within your recommendations report.
