Home Report

Single Survey

Property address	1/2 18 Hyndland Road Glasgow G12 9UP
Customer	Eilidh Macleod
Customer address	1/2 18 Hyndland Road Glasgow G12 9UP
Prepared by	Shepherd Chartered Surveyors
Date of inspection	05/01/2026

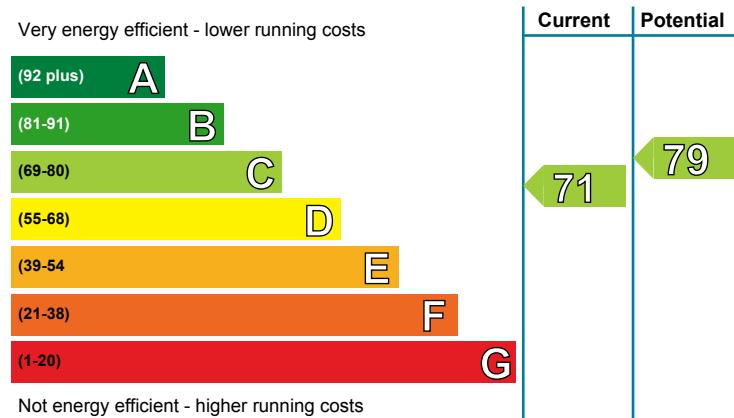
Energy Efficiency Rating

This graph shows the current efficiency of your home, taking into account both energy efficiency and fuel costs. The higher this rating, the lower your fuel bills are likely to be.

Your current rating is **band C (71)**. The average rating for EPCs in Scotland is **band D (61)**.

The potential rating shows the effect of undertaking all of the improvement measures listed within your recommendations report.

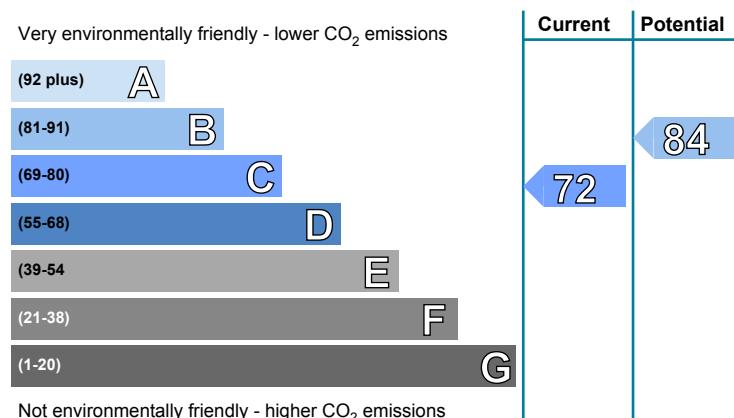
Environmental Impact (CO₂) Rating

This graph shows the effect of your home on the environment in terms of carbon dioxide (CO₂) emissions. The higher the rating, the less impact it has on the environment.
