Home Report

Single Survey

44 Burnside Road,
Largs,
Ayrshire,
KA30 9BY

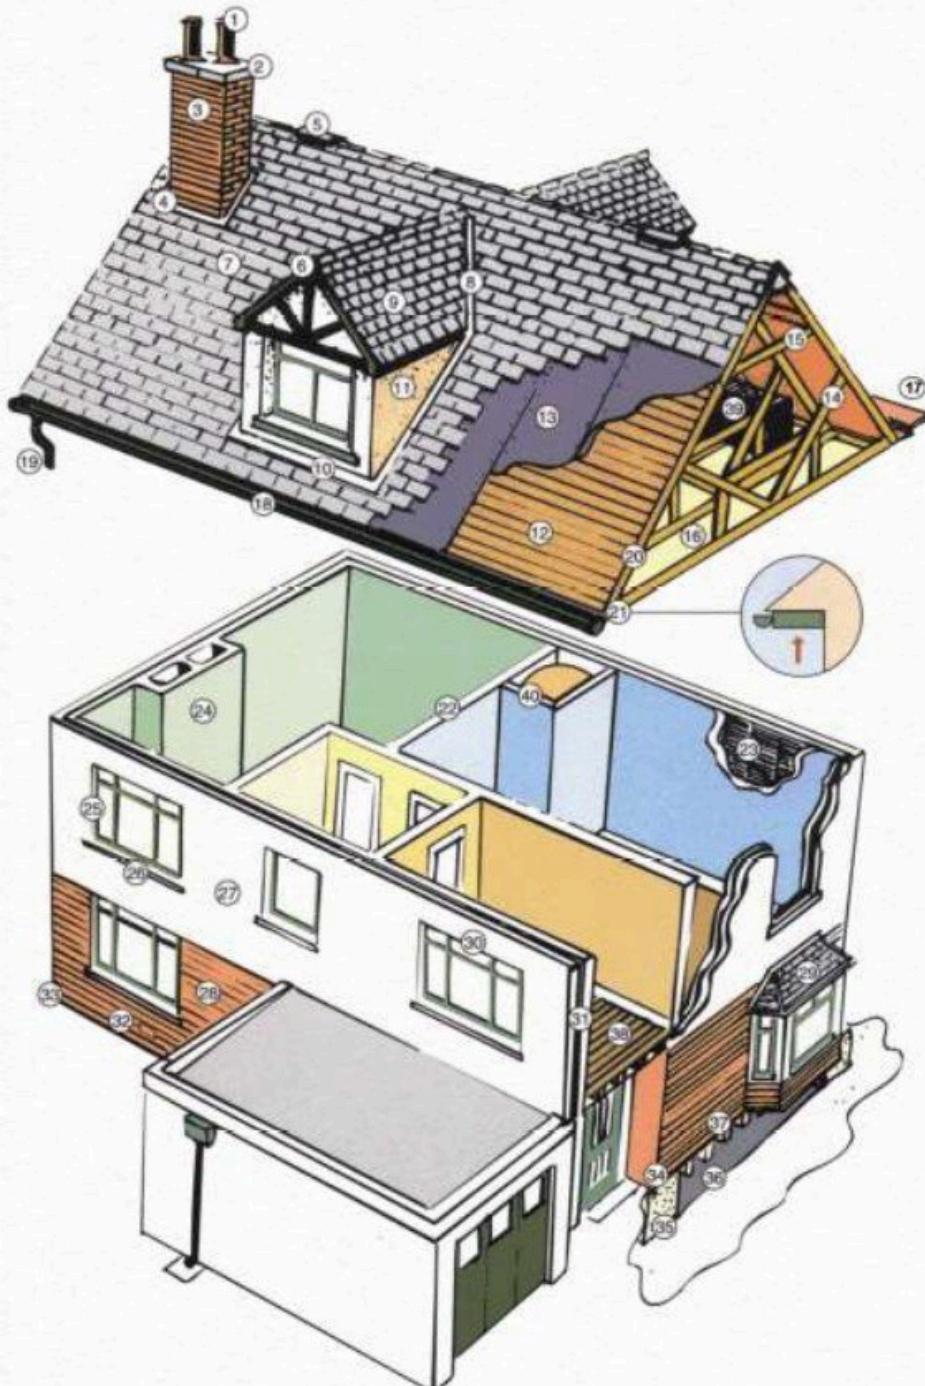
Sectional Diagram showing elements of a typical house

- 1 Chimney pots
- 2 Coping stone
- 3 Chimney head
- 4 Flashing
- 5 Ridge ventilation
- 6 Ridge board
- 7 Slates / tiles
- 8 Valley guttering
- 9 Dormer projection
- 10 Dormer flashing
- 11 Dormer cheeks
- 12 Sarking
- 13 Roof felt
- 14 Trusses
- 15 Collar
- 16 Insulation
- 17 Parapet gutter
- 18 Eaves guttering
- 19 Rainwater downpipe
- 20 Verge boards / skewers
- 21 Soffit boards
- 22 Partition wall
- 23 Lath / plaster
- 24 Chimney breast
- 25 Window pointing
- 26 Window sills
- 27 Rendering
- 28 Brickwork / pointing
- 29 Bay window projection
- 30 Lintels
- 31 Cavity walls / wall ties
- 32 Subfloor ventilator
- 33 Damp proof course
- 34 Base course
- 35 Foundations
- 36 Solum
- 37 Floor joists
- 38 Floorboards
- 39 Water tank
- 40 Hot water tank

Reference may be made in this report to some or all of the above component parts of the property. This diagram may assist you in locating and understanding these items.
