# Home Report

# Single Survey

## Survey Report on:

<b>Property Address</b>	112 Cowcaddens Road, GLASGOW, G4 0HL
<b>Reference</b>	1591318
<b>Customer Name</b>	Egle Vysniauskaite Craig Sinclair
<b>Date of Inspection</b>	20th May 2026
<b>Surveyor's name, qualifications and office</b>	Paul Reilly BSc, MRICS DM Hall LLP Chartered Surveyors 3 Centura Court, Hillington Park Glasgow G52 4PR  Tel: 0141 636 4141  email: glasgowresidential@dmhall.co.uk
<b>Prepared By</b>	DM Hall LLP

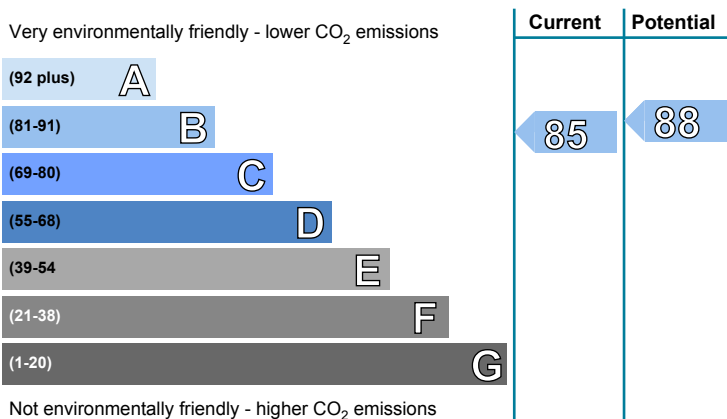
## Environmental Impact (CO<sub>2</sub>) Rating

This graph shows the effect of your home on the environment in terms of carbon dioxide (CO<sub>2</sub>) emissions. The higher the rating, the less impact it has on the environment.
