Home Report

Single Survey

Property address	2/1 19 Beechlands Avenue Glasgow G44 3YT
Customer	Mr & Mrs Brennan
Customer address	2/1 19 Beechlands Avenue Glasgow G44 3YT
Prepared by	Shepherd Chartered Surveyors
Date of inspection	02/02/2026

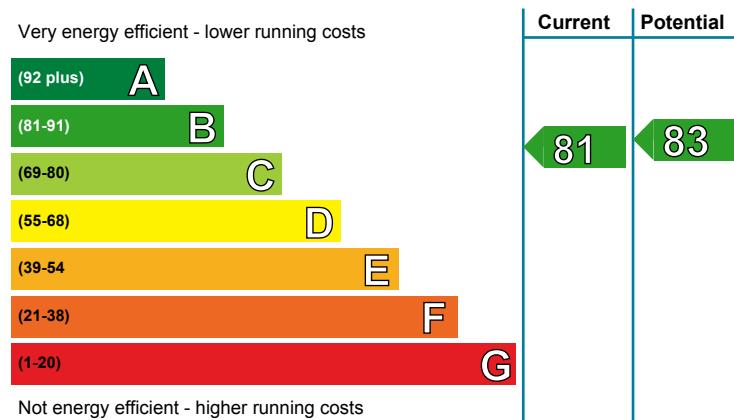
Energy Efficiency Rating

This graph shows the current efficiency of your home, taking into account both energy efficiency and fuel costs. The higher this rating, the lower your fuel bills are likely to be.

Your current rating is **band B (81)**. The average rating for EPCs in Scotland is **band D (61)**.

The potential rating shows the effect of undertaking all of the improvement measures listed within your recommendations report.

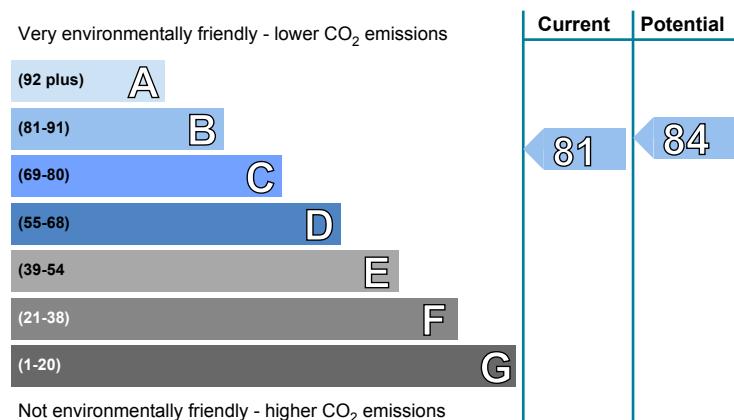
Environmental Impact (CO₂) Rating

This graph shows the effect of your home on the environment in terms of carbon dioxide (CO₂) emissions. The higher the rating, the less impact it has on the environment.
