Home Report

Single Survey

Property address	East Overton Paddock Hamilton Road Strathaven ML10 6SZ
Customer	Christine Marshall
Customer address	East Overton Paddock Hamilton Road Strathaven ML10 6SZ
Prepared by	Shepherd Chartered Surveyors
Date of inspection	26/01/2026

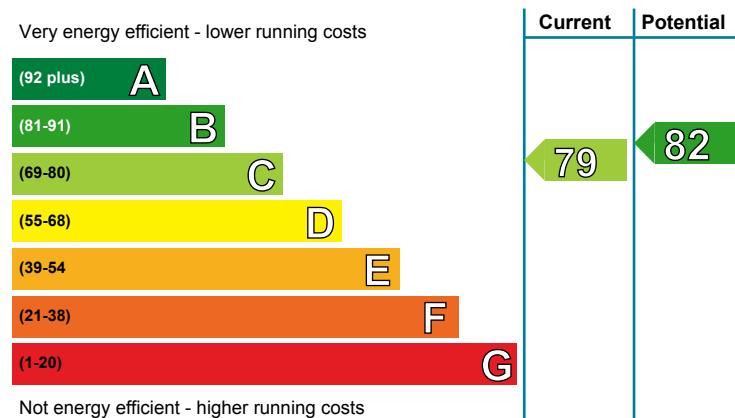
Energy Efficiency Rating

This graph shows the current efficiency of your home, taking into account both energy efficiency and fuel costs. The higher this rating, the lower your fuel bills are likely to be.

Your current rating is **band C (79)**. The average rating for EPCs in Scotland is **band D (61)**.

The potential rating shows the effect of undertaking all of the improvement measures listed within your recommendations report.

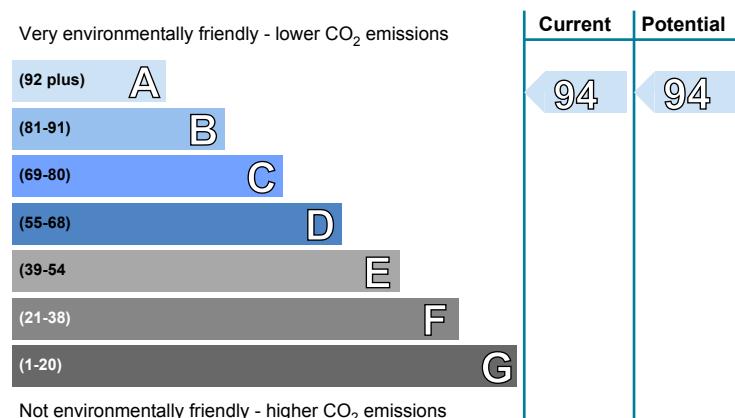
Environmental Impact (CO₂) Rating

This graph shows the effect of your home on the environment in terms of carbon dioxide (CO₂) emissions. The higher the rating, the less impact it has on the environment.
