Home Report

Single Survey

Property address	23 Patrickbank Crescent Elderslie Johnstone PA5 9UG
Customer	Kirsty Smart
Customer address	23 Patrickbank Crescent Elderslie Johnstone PA5 9UG
Prepared by	Shepherd Chartered Surveyors
Date of inspection	20/01/2026

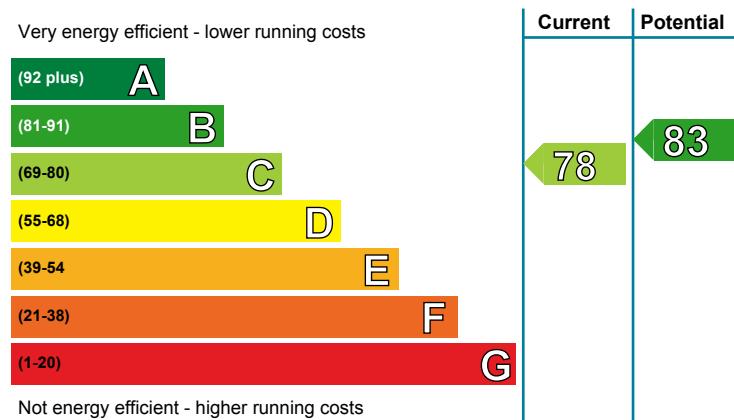
Energy Efficiency Rating

This graph shows the current efficiency of your home, taking into account both energy efficiency and fuel costs. The higher this rating, the lower your fuel bills are likely to be.

Your current rating is **band C (78)**. The average rating for EPCs in Scotland is **band D (61)**.

The potential rating shows the effect of undertaking all of the improvement measures listed within your recommendations report.

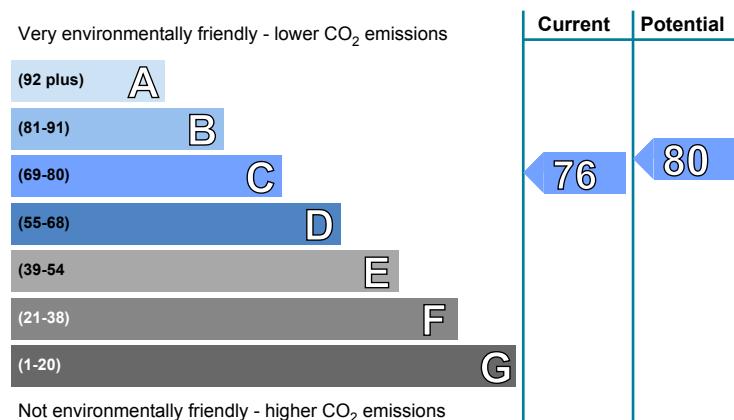
Environmental Impact (CO₂) Rating

This graph shows the effect of your home on the environment in terms of carbon dioxide (CO₂) emissions. The higher the rating, the less impact it has on the environment.
