YOUR ONESURVEY
HOME REPORT

45 Millfield View
Erskine
PA8 6HE

Single Survey

Surveyor Reference	PD/9463
Customer	Jane Graham
Selling address	45 Millfield View Erskine PA8 6HE
Date of Inspection	29/01/2026
Prepared by	Mark Stewart, BSc Hons MRICS Paisley - Allied Surveyors Scotland Ltd

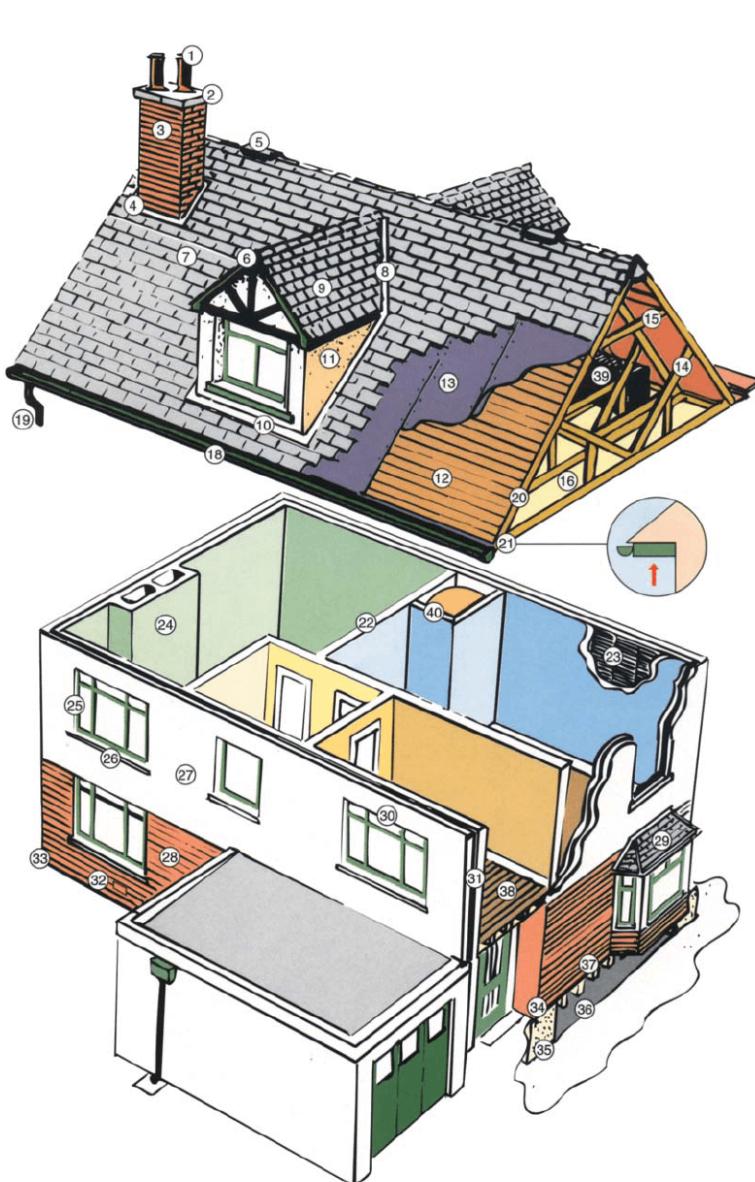
Sectional Diagram showing elements of a typical house

- 1 Chimney pots
- 2 Coping stone
- 3 Chimney head
- 4 Flashing
- 5 Ridge ventilation
- 6 Ridge board
- 7 Slates / tiles
- 8 Valley guttering
- 9 Dormer projection
- 10 Dormer flashing
- 11 Dormer cheeks
- 12 Sarking
- 13 Roof felt
- 14 Trusses
- 15 Collar
- 16 Insulation
- 17 Parapet gutter
- 18 Eaves guttering
- 19 Rainwater downpipe
- 20 Verge boards / skewers
- 21 Soffit boards
- 22 Partition wall
- 23 Lath / plaster
- 24 Chimney breast
- 25 Window pointing
- 26 Window sills
- 27 Rendering
- 28 Brickwork / pointing
- 29 Bay window projection
- 30 Lintels
- 31 Cavity walls / wall ties
- 32 Subfloor ventilator
- 33 Damp proof course
- 34 Base course
- 35 Foundations
- 36 Solum
- 37 Floor joists
- 38 Floorboards
- 39 Water tank
- 40 Hot water tank

Reference may be made in this report to some or all of the above component parts of the property. This diagram may assist you in locating and understanding these items.

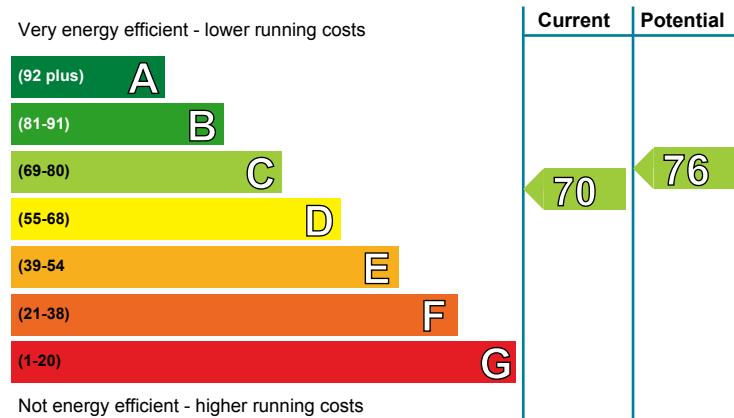
Energy Efficiency Rating

This graph shows the current efficiency of your home, taking into account both energy efficiency and fuel costs. The higher this rating, the lower your fuel bills are likely to be.

Your current rating is **band C (70)**. The average rating for EPCs in Scotland is **band D (61)**.

The potential rating shows the effect of undertaking all of the improvement measures listed within your recommendations report.
