# Home Report

# Scottish Single Survey

<b>Property address</b>	Flat 9 46 Partick Bridge Street Glasgow G11 6PQ
<b>Customer</b>	Marianne Gallagher, Andrew Synnot & Angela Synnot
<b>Customer address</b>	Flat 9 46 Partick Bridge Street Glasgow G11 6PQ
<b>Prepared by</b>	Shepherd Chartered Surveyors
<b>Date of inspection</b>	19/01/2026

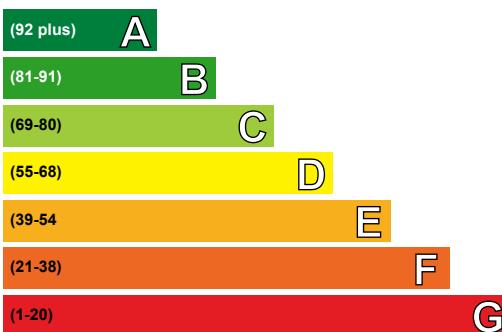
## Energy Efficiency Rating

Very energy efficient - lower running costs

Current	Potential
81	81

Not energy efficient - higher running costs
