Home Report

Single Survey

Property address	Ground Floor 20 Winton Drive Kelvinside Glasgow G12 0QA
Customer	R Archibald
Customer address	Ground Floor 20 Winton Drive Kelvinside Glasgow G12 0QA
Prepared by	Shepherd Chartered Surveyors
Date of inspection	26/01/2026

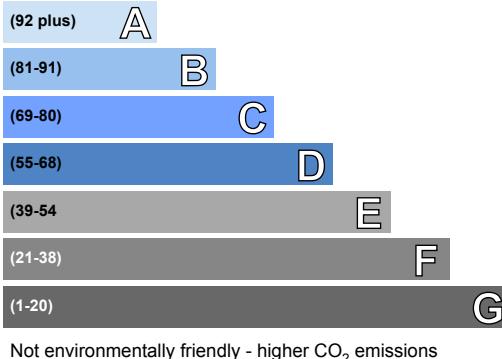
Environmental Impact (CO₂) Rating

Very environmentally friendly - lower CO₂ emissions
