Home Report

Scottish Single Survey

Single Survey

Property address	The Shieling Sorn Mauchline KA5 6JA
Customer	Mr J Murdoch
Customer address	The Shieling Sorn Mauchline KA5 6JA
Prepared by	Shepherd Chartered Surveyors
Date of inspection	03/02/2026

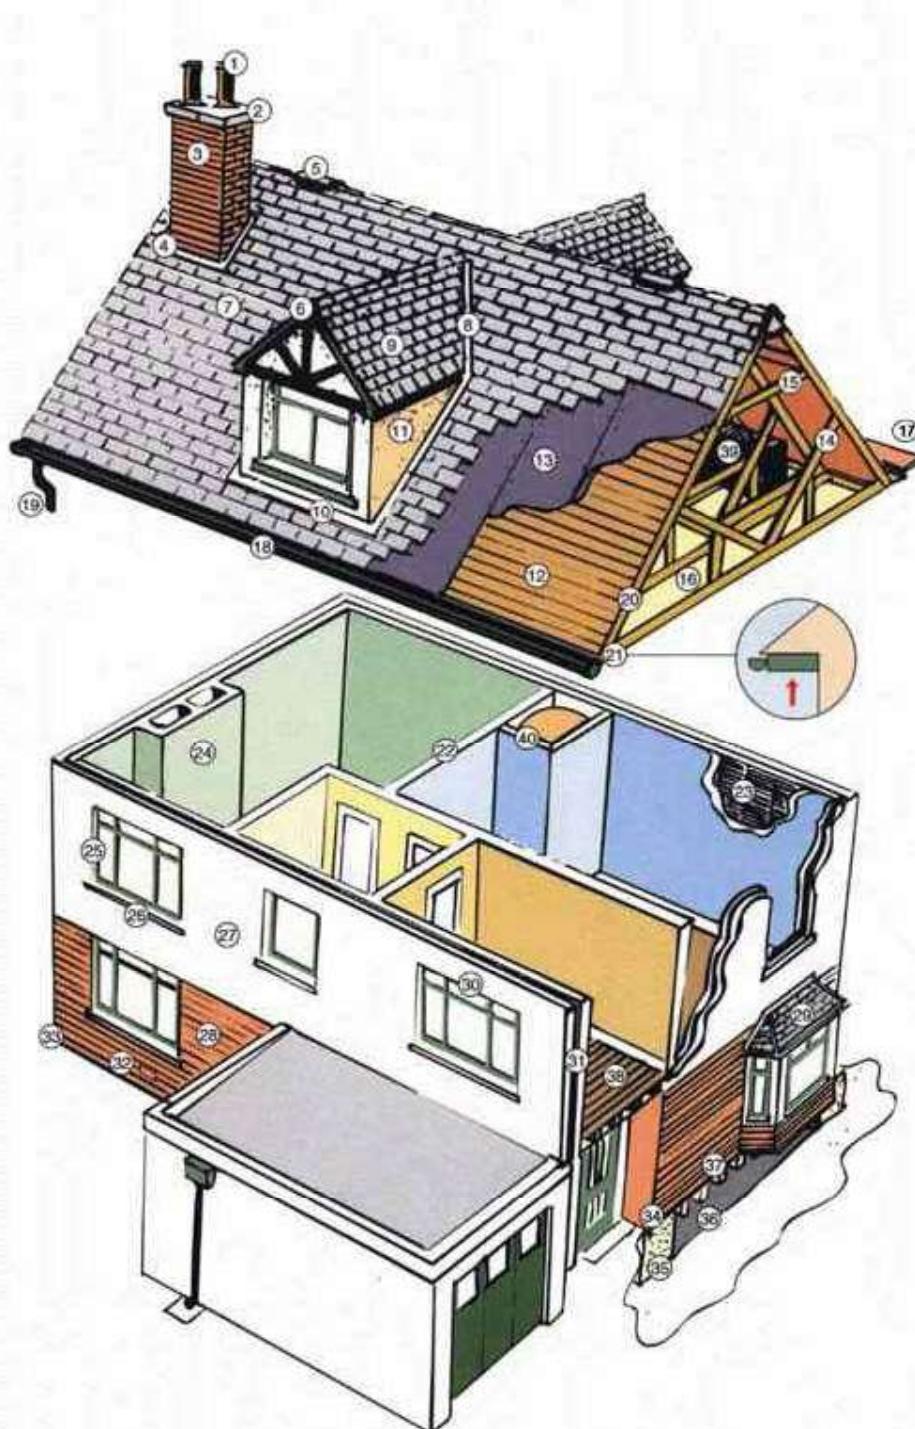
Sectional Diagram showing elements of a typical house

- 1 Chimney pots
- 2 Coping stone
- 3 Chimney head
- 4 Flashing
- 5 Ridge ventilation
- 6 Ridge board
- 7 Slates / tiles
- 8 Valley guttering
- 9 Dormer projection
- 10 Dormer flashing
- 11 Dormer cheeks
- 12 Sarking
- 13 Roof felt
- 14 Trusses
- 15 Collar
- 16 Insulation
- 17 Parapet gutter
- 18 Eaves guttering
- 19 Rainwater downpipe
- 20 Verge boards /skews
- 21 Soffit boards
- 22 Partition wall
- 23 Lath / plaster
- 24 Chimney breast
- 25 Window pointing
- 26 Window sills
- 27 Rendering
- 28 Brickwork / pointing
- 29 Bay window projection
- 30 Lintels
- 31 Cavity walls / wall ties
- 32 Subfloor ventilator
- 33 Damp proof course
- 34 Base course
- 35 Foundations
- 36 Solum
- 37 Floor joists
- 38 Floorboards
- 39 Water tank
- 40 Hot water tank

Reference may be made in this report to some or all of the above component parts of the property. This diagram may assist you in locating and understanding these items.

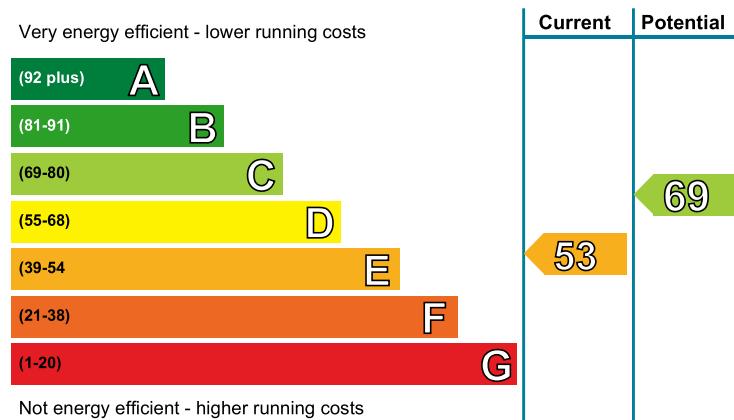
Energy Efficiency Rating

This graph shows the current efficiency of your home, taking into account both energy efficiency and fuel costs. The higher this rating, the lower your fuel bills are likely to be.

Your current rating is **band E (53)**. The average rating for EPCs in Scotland is **band D (61)**.

The potential rating shows the effect of undertaking all of the improvement measures listed within your recommendations report.

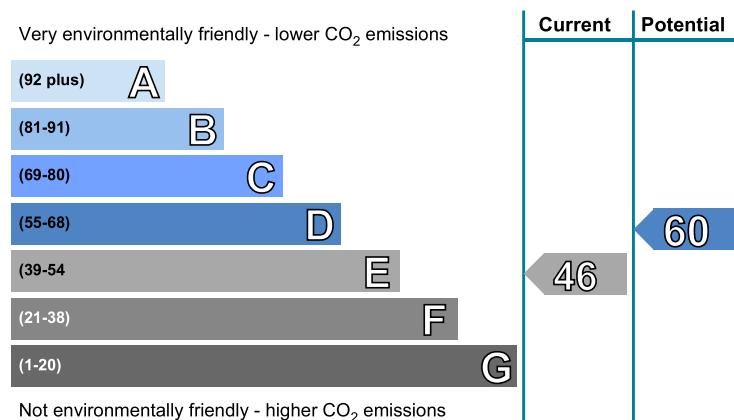
Environmental Impact (CO₂) Rating

This graph shows the effect of your home on the environment in terms of carbon dioxide (CO₂) emissions. The higher the rating, the less impact it has on the environment.
