Home Report

Scottish Single Survey

Property address	21 Bluebell Drive Newton Mearns Glasgow G77 6FN
Customer	MR GEORGE MACDONALD
Customer address	21 Bluebell Drive Newton Mearns Glasgow G77 6FN
Prepared by	Shepherd Chartered Surveyors
Date of inspection	24/02/2026

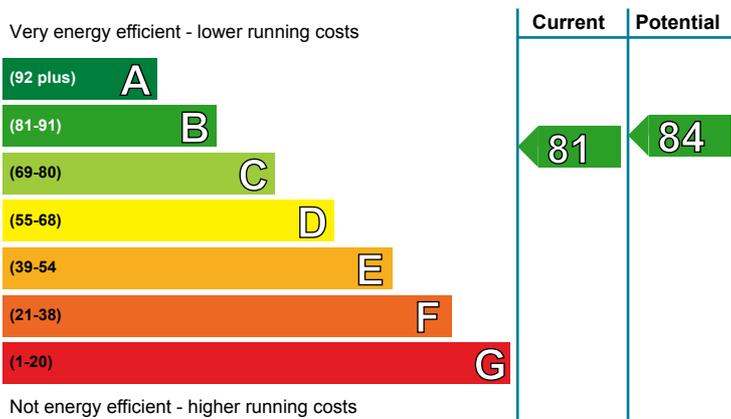
Energy Efficiency Rating

This graph shows the current efficiency of your home, taking into account both energy efficiency and fuel costs. The higher this rating, the lower your fuel bills are likely to be.

Your current rating is **band B (81)**. The average rating for EPCs in Scotland is **band D (61)**.

The potential rating shows the effect of undertaking all of the improvement measures listed within your recommendations report.
