YOUR ONESURVEY  
**HOME REPORT**

22 Millbank Crescent  
Bishopton  
PA7 5NQ

# SINGLE SURVEY

# Single Survey

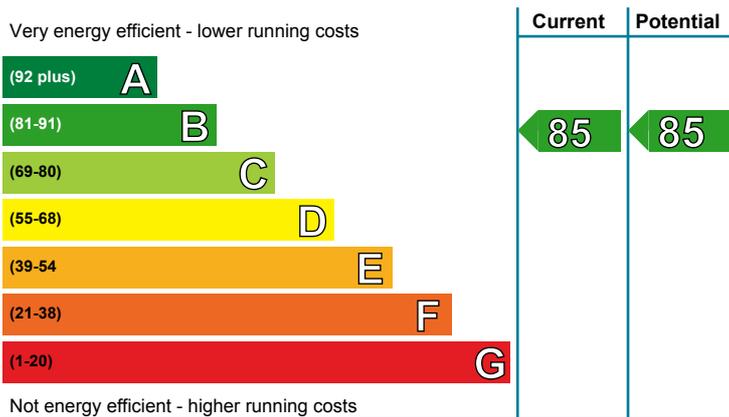
## Energy Efficiency Rating

This graph shows the current efficiency of your home, taking into account both energy efficiency and fuel costs. The higher this rating, the lower your fuel bills are likely to be.

Your current rating is **band B (85)**. The average rating for EPCs in Scotland is **band D (61)**.

The potential rating shows the effect of undertaking all of the improvement measures listed within your recommendations report.
