# Home Report

# Scottish Single Survey

<b>Property address</b>	Lonach 16 Hillside Road Barrhead Glasgow G78 1ES
<b>Customer</b>	Douglas Forbes
<b>Customer address</b>	Lonach 16 Hillside Road Barrhead Glasgow G78 1ES
<b>Prepared by</b>	Shepherd Chartered Surveyors
<b>Date of inspection</b>	06/02/2026

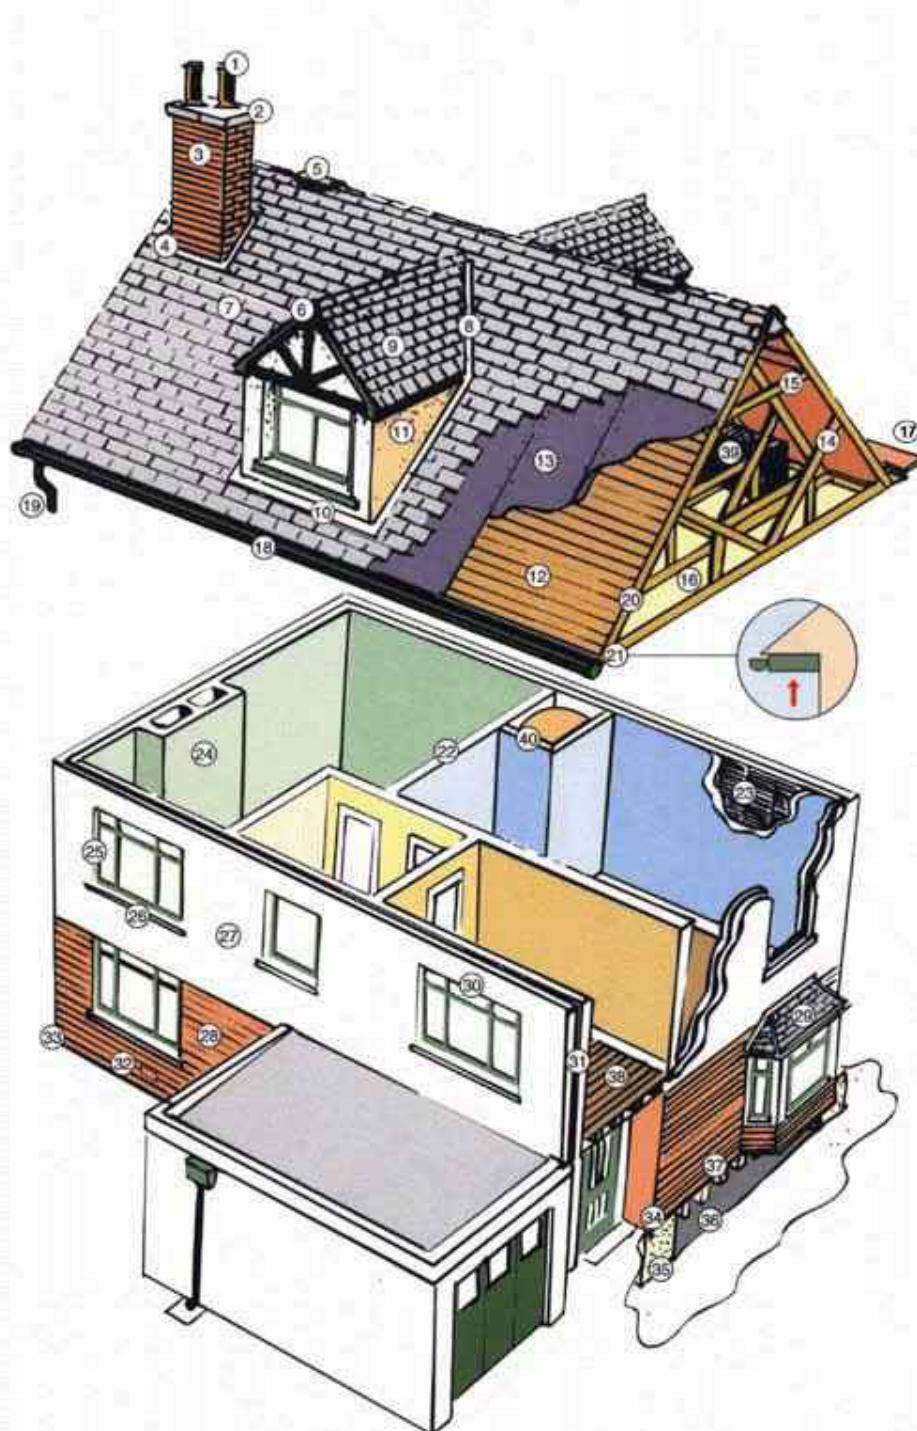
## Sectional Diagram showing elements of a typical house

- 1 Chimney pots
- 2 Coping stone
- 3 Chimney head
- 4 Flashing
- 5 Ridge ventilation
- 6 Ridge board
- 7 Slates / tiles
- 8 Valley guttering
- 9 Dormer projection
- 10 Dormer flashing
- 11 Dormer cheeks
- 12 Sarking
- 13 Roof felt
- 14 Trusses
- 15 Collar
- 16 Insulation
- 17 Parapet gutter
- 18 Eaves guttering
- 19 Rainwater downpipe
- 20 Verge boards /skews
- 21 Soffit boards
- 22 Partition wall
- 23 Lath / plaster
- 24 Chimney breast
- 25 Window pointing
- 26 Window sills
- 27 Rendering
- 28 Brickwork / pointing
- 29 Bay window projection
- 30 Lintels
- 31 Cavity walls / wall ties
- 32 Subfloor ventilator
- 33 Damp proof course
- 34 Base course
- 35 Foundations
- 36 Solum
- 37 Floor joists
- 38 Floorboards
- 39 Water tank
- 40 Hot water tank

Reference may be made in this report to some or all of the above component parts of the property. This diagram may assist you in locating and understanding these items.

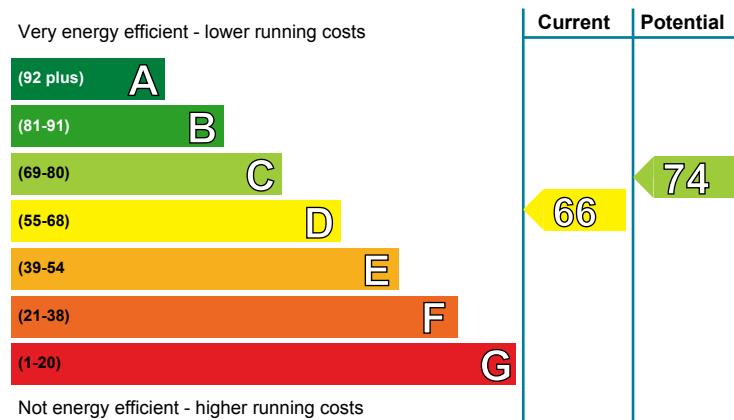
## Energy Efficiency Rating

This graph shows the current efficiency of your home, taking into account both energy efficiency and fuel costs. The higher this rating, the lower your fuel bills are likely to be.

Your current rating is **band D (66)**. The average rating for EPCs in Scotland is **band D (61)**.

The potential rating shows the effect of undertaking all of the improvement measures listed within your recommendations report.

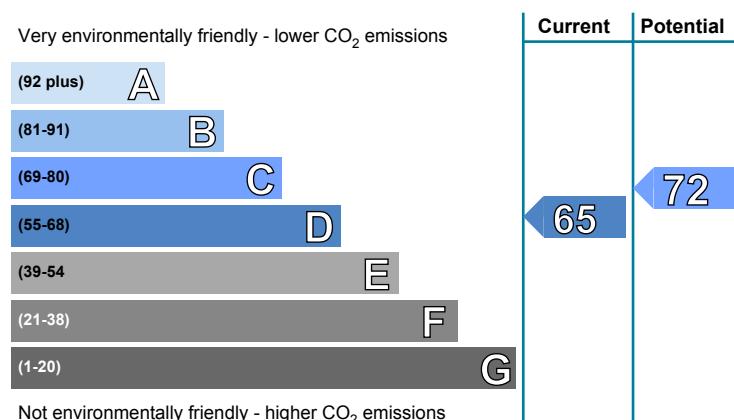
## Environmental Impact (CO<sub>2</sub>) Rating

This graph shows the effect of your home on the environment in terms of carbon dioxide (CO<sub>2</sub>) emissions. The higher the rating, the less impact it has on the environment.
