Home Report

Single Survey

Property address	47h Bellshaugh Gardens Glasgow G12 0SA
Customer	Giulia Magro
Customer address	47h Bellshaugh Gardens Glasgow G12 0SA
Prepared by	Shepherd Chartered Surveyors
Date of inspection	13/02/2026

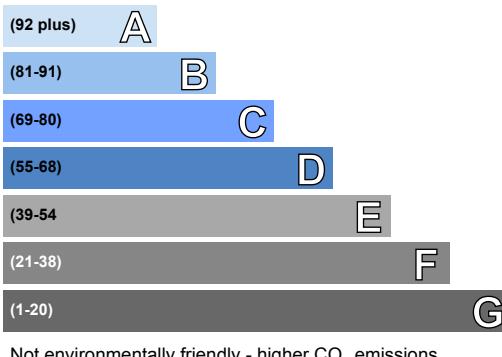
Environmental Impact (CO₂) Rating

Very environmentally friendly - lower CO₂ emissions
