Home Report

Single Survey

Property address	67 Braes O Yetts Drive Kirkintilloch Glasgow G66 3FF
Customer	Mr & Mrs Stuart & Lorna Anderson
Customer address	67 Braes O Yetts Drive Kirkintilloch Glasgow G66 3FF
Prepared by	Shepherd Chartered Surveyors
Date of inspection	03/02/2026

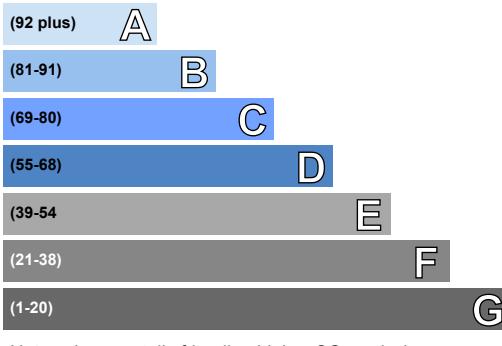
Environmental Impact (CO₂) Rating

Very environmentally friendly - lower CO₂ emissions

Current	Potential
	86	86
