# YOUR ONESURVEY HOME REPORT

2/1  
27 Arundel Drive  
Glasgow  
G42 9RG

# SINGLE SURVEY

A report on the condition of the property, with categories  
being rated from 1 to 3.

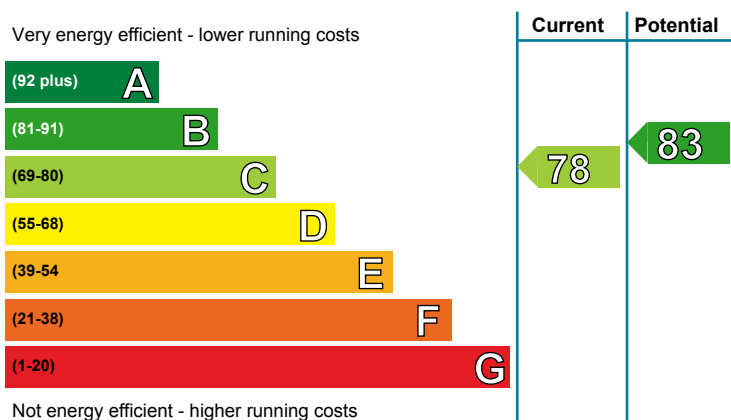
## Energy Efficiency Rating

This graph shows the current efficiency of your home, taking into account both energy efficiency and fuel costs. The higher this rating, the lower your fuel bills are likely to be.

Your current rating is **band C (78)**. The average rating for EPCs in Scotland is **band D (61)**.

The potential rating shows the effect of undertaking all of the improvement measures listed within your recommendations report.

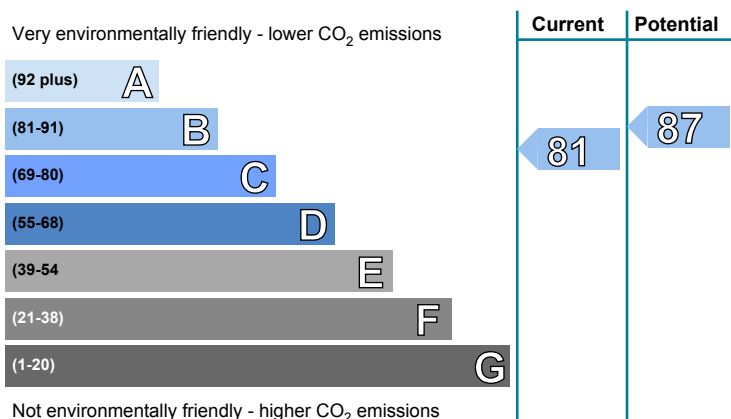
## Environmental Impact (CO<sub>2</sub>) Rating

This graph shows the effect of your home on the environment in terms of carbon dioxide (CO<sub>2</sub>) emissions. The higher the rating, the less impact it has on the environment.
