Home Report

Scottish Single Survey

Property address	Flat 2/2 Holmwood Heights 80 Inverlair Avenue G43 2BD
Customer	FMG Devs Ltd
Customer address	Flat 2/2 Holmwood Heights 80 Inverlair Avenue G43 2BD
Prepared by	Shepherd Chartered Surveyors
Date of inspection	02/03/2026

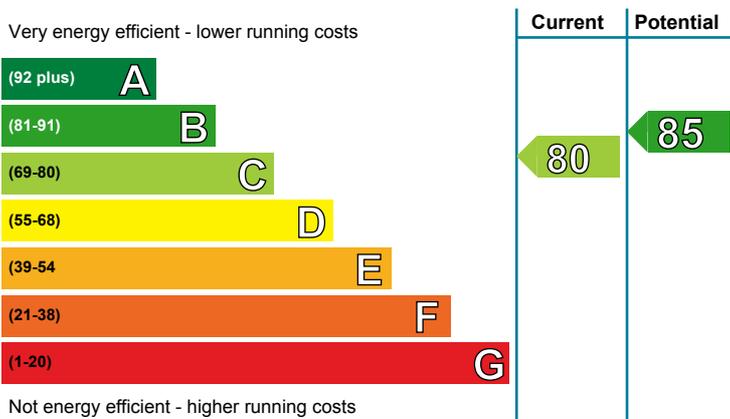
Energy Efficiency Rating

This graph shows the current efficiency of your home, taking into account both energy efficiency and fuel costs. The higher this rating, the lower your fuel bills are likely to be.

Your current rating is **band C (80)**. The average rating for EPCs in Scotland is **band D (61)**.

The potential rating shows the effect of undertaking all of the improvement measures listed within your recommendations report.

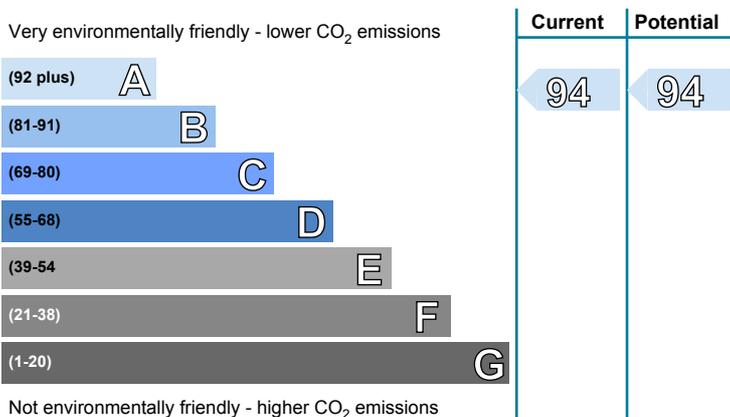
Environmental Impact (CO₂) Rating

This graph shows the effect of your home on the environment in terms of carbon dioxide (CO₂) emissions. The higher the rating, the less impact it has on the environment.
