Home Report

Scottish Single Survey

Property address	33 Harling Drive Troon KA10 6NG
-------------------------	---------------------------------------

Prepared by	Shepherd Chartered Surveyors
--------------------	------------------------------

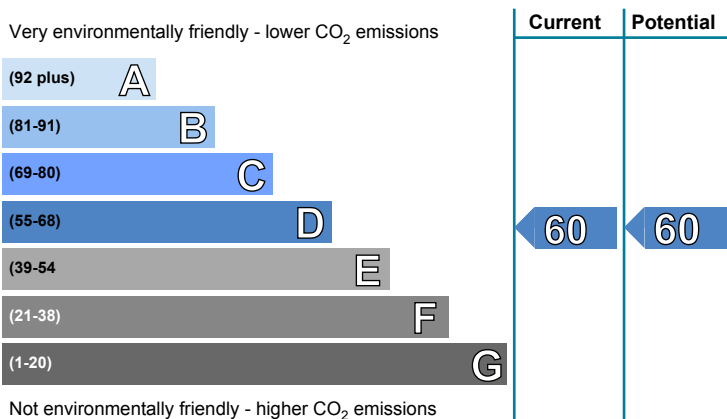
Environmental Impact (CO₂) Rating

This graph shows the effect of your home on the environment in terms of carbon dioxide (CO₂) emissions. The higher the rating, the less impact it has on the environment.
