Home Report

Single Survey

Property address	3a Mill Road Bothwell Glasgow G71 8DQ
-------------------------	--

Prepared by	Shepherd Chartered Surveyors
--------------------	------------------------------

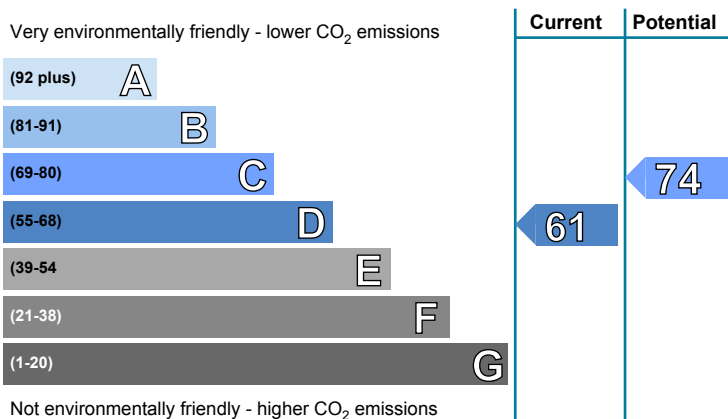
Environmental Impact (CO₂) Rating

This graph shows the effect of your home on the environment in terms of carbon dioxide (CO₂) emissions. The higher the rating, the less impact it has on the environment.
