YOUR ONESURVEY
HOME REPORT

Flat 2/2
1 Novar Drive
Hyndland
Glasgow, G12 9PX

SINGLE SURVEY

Single Survey

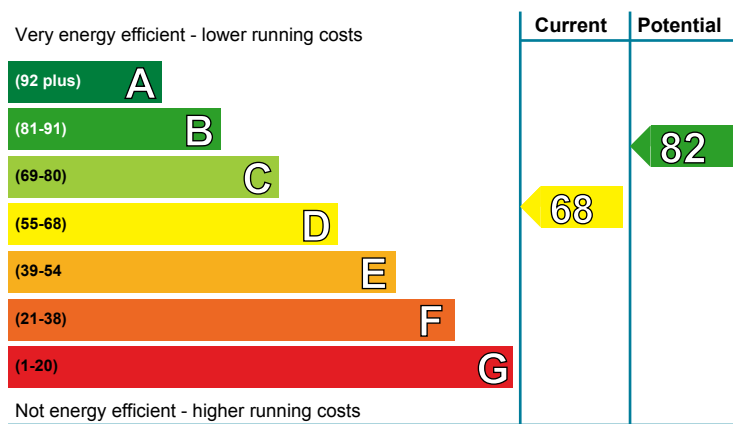
Energy Efficiency Rating

This graph shows the current efficiency of your home, taking into account both energy efficiency and fuel costs. The higher this rating, the lower your fuel bills are likely to be.

Your current rating is **band D (68)**. The average rating for EPCs in Scotland is **band D (61)**.

The potential rating shows the effect of undertaking all of the improvement measures listed within your recommendations report.

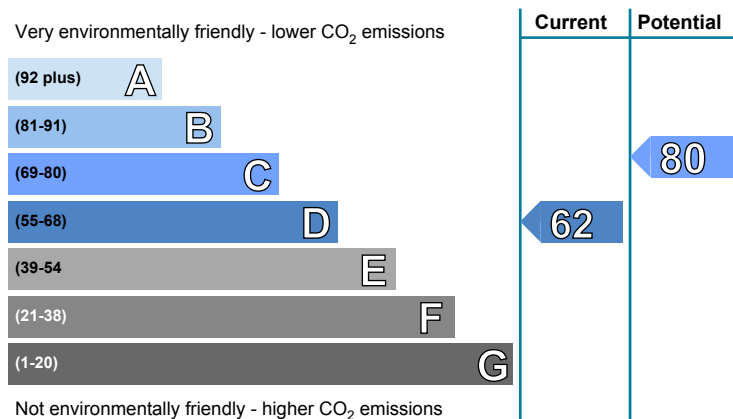
Environmental Impact (CO₂) Rating

This graph shows the effect of your home on the environment in terms of carbon dioxide (CO₂) emissions. The higher the rating, the less impact it has on the environment.
