YOUR ONESURVEY  
**HOME REPORT**

2a Devonshire Terrace  
Hyndland  
Glasgow  
G12 0XE

# SINGLE SURVEY

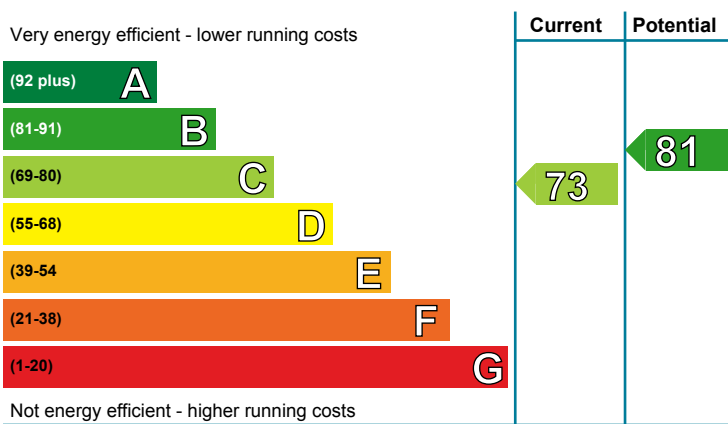
## Energy Efficiency Rating

This graph shows the current efficiency of your home, taking into account both energy efficiency and fuel costs. The higher this rating, the lower your fuel bills are likely to be.

Your current rating is **band C (73)**. The average rating for EPCs in Scotland is **band D (61)**.

The potential rating shows the effect of undertaking all of the improvement measures listed within your recommendations report.
